Deer Stand Hill: An Architectural Survey
of Historic Buildings in Downtown Troy, Alabama

prepared for
The Pike County Chamber of Commerce, Inc.
101A East Church Street
Troy, Alabama 36081

by
Laura Lee Corbett
and
Tray G. Earnest, RPA
TG. Earnest & Associates, LLC
511 2nd Avenue
Troy, Alabama 36081

September 26, 2012

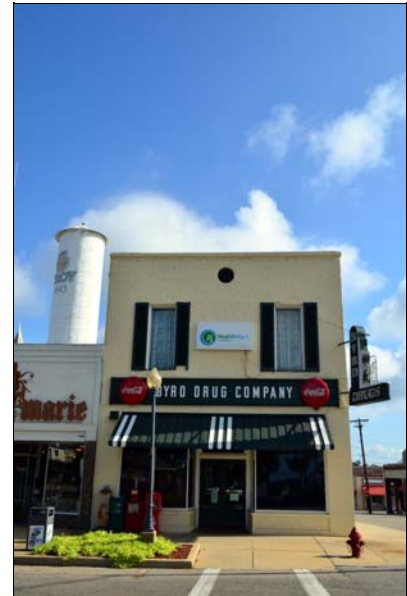
Figure 4.1. Byrd Drug, south elevation.

This commercial vernacular building retains a significant level of historic fabric. The street level Court square exhibits a double wooden door with decorative transom light, bordered by display windows. Two secondary entrances are located on Oak Street and one on the alley at the building's rear. Upper story windows appear to be modern replacements in examples not covered with shutters. Original windows on the second story west elevation are have been enclosed. A simple parapet with masonry coping surrounds a gabled roof. Preservation condition is considered good.

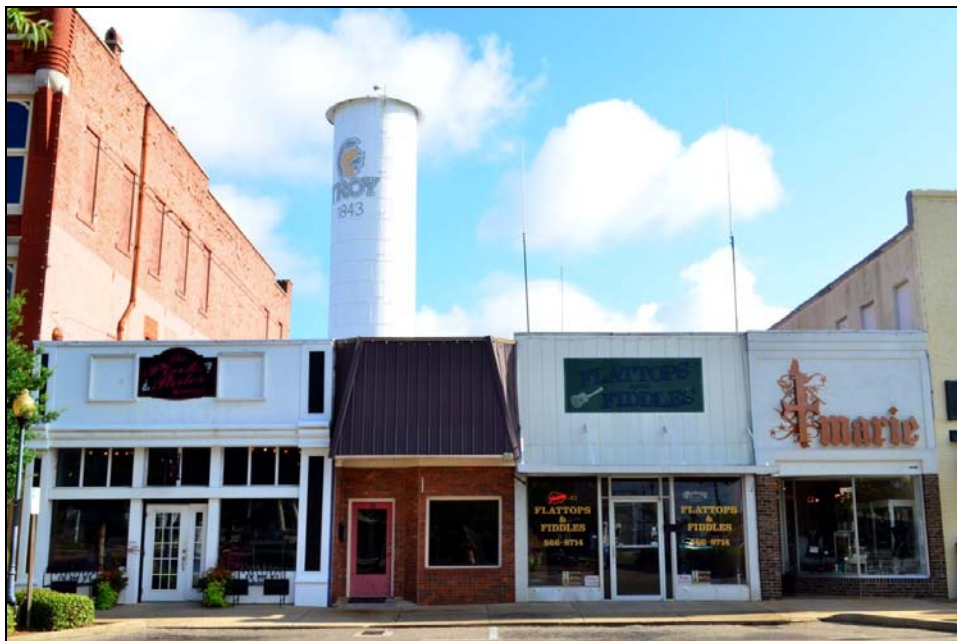
Figure 4.4. South elevation at T-Marie, Flattops, Cutting Edge and Pink Parlor (right to left).

This one-story commercial vernacular building has been altered with modern brick, display windows and door (Figure 4.4). The upper half of the entrance facade retains a paneled parapet. Listed construction date is 1900, but the building likely predates 1885. Preservation condition is good.

This one-story commercial vernacular building has been altered with modern display windows and door (Figure 4.4). The upper half of the entrance facade retains a parapet covered in aluminum siding. Listed construction date is 1900, but the building likely predates 1885. Preservation condition is good.

This building is considered ineligible for nomination to the *NRHP* due to contemporary updates and limited historic fabric. This building is considered potentially eligible for the Alabama Register based on antiquity, overall preservation condition, and its contribution to the historic setting of Downtown Troy. Future alterations should incorporate more historically appropriate materials in order to improve the historic character of the front elevation.

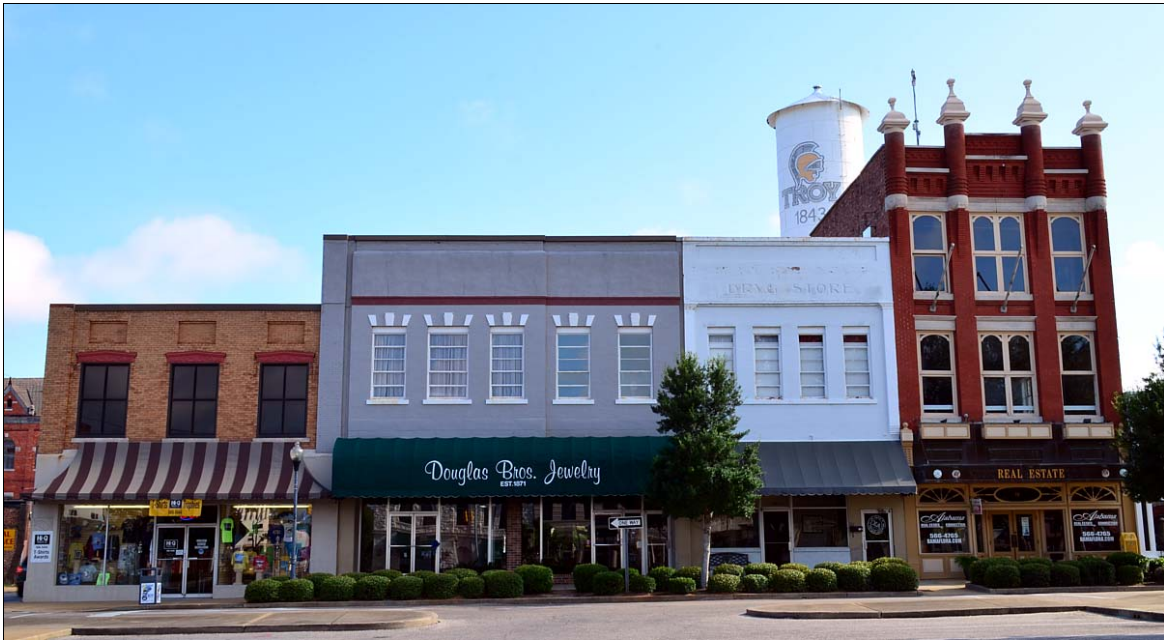
Figure 4.5. Gellerstedt, Watkins, Douglas Brothers, and Hi-Q buildings (right to left).

This prominent three-story building was constructed to house the Gellerstedt clothing business, founded circa 1871 by brothers Lawrence E. and Sam W. Gellerstedt (Figure 4.5). The building was constructed by Enoch Crites, the same architect/builder as the Masonic Building at Walnut and Elm Streets (Farmer 1992:40). The Gellerstedt Building is listed in the property appraiser data being built in 1890. A *Messenger* article dated 1894 indicates that the business was in existence for nineteen years as of that year, implying an approximate construction date (or business startup date) of 1871 (Farmer 1992:315). Sanborn maps show this location as a one-story building in 1885 (1), 1891 (1), and 1892 (2). The building is finally

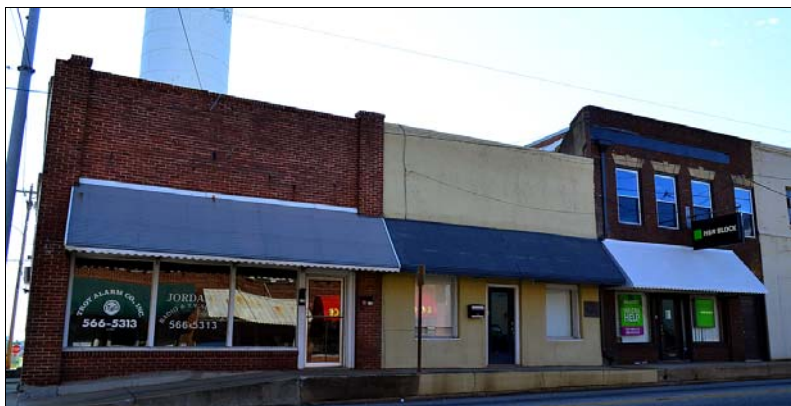
Figure 4.6. HR block, Coots, Jordans, west elevation.

This two-story commercial vernacular building has been altered at street level with modern display windows and door. A secondary entrance door for second floor access has also been replaced with a modern door, but the entrance retains an arched transom light bordered by soldiered brick (Figure 4.6).

The second floor appears to retain original keystone lintels over presumably modern single-pane, sashed windows. This second floor level is depicted as “sleeping rooms” on the 1885 Sanborn map (1). A simple brick parapet with plain brick coping is present at the

This one-story commercial vernacular building has been altered at street level with modern display windows and door (Figure 4.6). A simple parapet with plain brick coping is present at the front elevation. The presumed brick at the front elevation is covered with painted plaster. An aluminum awning shades the front entrance. Listed construction date is 1900, but the building likely predates 1885. Preservation condition is considered good.

This one-story commercial vernacular building is flanked on both sides by shallow brick pilasters that extend to the top of the building's front elevation (Figure 4.6). A simple brick parapet with brick coping extends around the building perimeter. The street level facade has been with modern display windows and door. An aluminum awning shades the front entrance. Listed construction date is 1900, but the building likely predates 1885. Preservation condition is considered good.

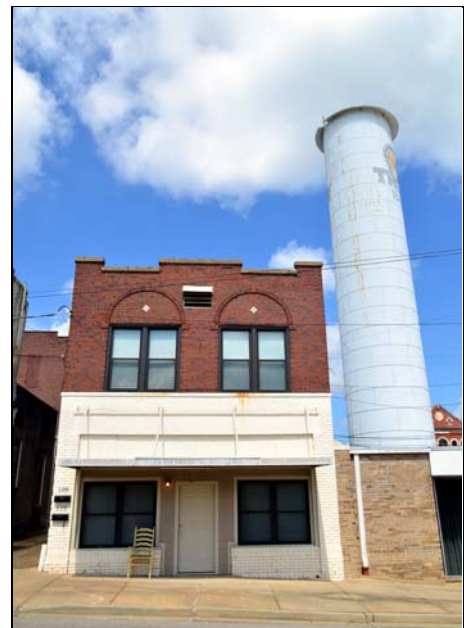
Figure 4.7. West view of water tower and 11-37 east elevation.

This metal standpipe structure was built as part of the 1895 public utilities project designed to bring fresh water to the Downtown area for sale to local businesses and for fire protection (Figure 4.7; Farmer 1992:262). This structure is potentially eligible for nomination to the *NRHP* under *Criteria A* and *C* and eligible for the Alabama Register under the same general criteria due to its association with one of the earliest public utilities projects in Pike County. Preservation condition is considered good. This structure is a prominent historic landmark and should be actively protected and preserved for future generations.

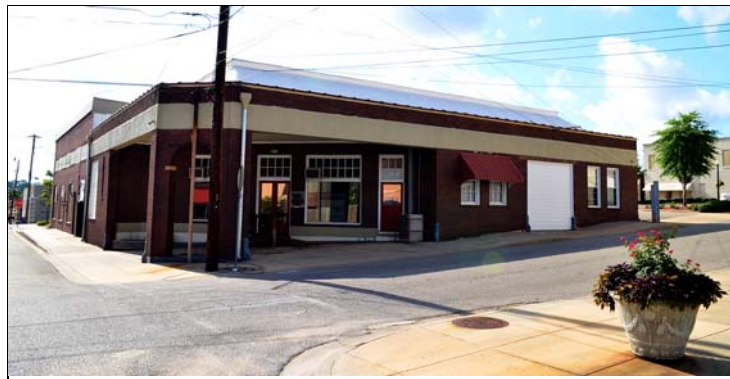
Figure 4.8. Southeast view of O’Neil Motor Company Building.

This commercial vernacular building once housed the O’Neil Motor Company, and serves as one of only two surviving corner entrance facade buildings in downtown Troy (Figure 4.8). The unique corner entrance facade contains a primary entrance consisting of double wooden doors with 4/4 fixed transom light. Two large display windows with 7/7 fixed transom lights flank the main entrance. Matching single-door alternate entrances with 3/3 fixed transom lights are located at the far left and right sides of the main

corner facade. Freight doors for vehicle access and goods delivery are located on the Oak Street and Walnut Street facades. The property appraisers listed construction date is 1920, but this building is not depicted on the 1923 (3) Sanborn map. It is, however, depicted on the 1931(3) version. Further research is needed to determine the actual construction date between 1923 and 1931.

This one-story commercial vernacular building was part of the O’Neil Motor Company complex that spanned the majority of Block 10 facing Walnut Street (Figures 4.8, 4.9). The 1923 (3) Sanborn map indicates that this building actually predates the adjacent O’Neil Motor Company building, which was not constructed until ca. 1931 (Sanborn 1931:3). Additionally, this building is listed as vacant on the 1931 (3) Sanborn map.

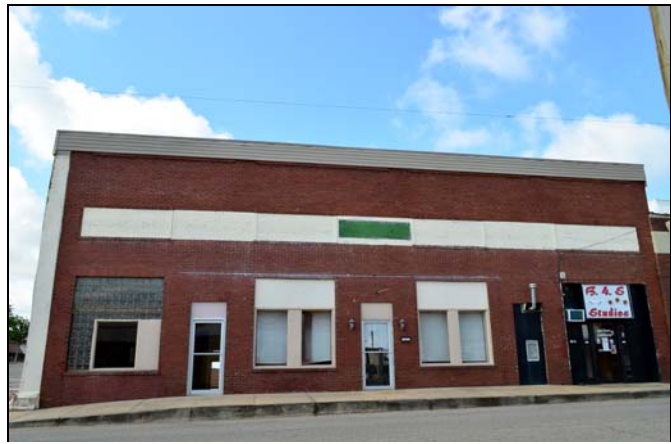
Figure 4.9. North elevation at O’Neil Motor Company Annex.

The original layout of pedestrian and vehicle entrances have been altered on the Walnut street facade to accommodate interior building subdivision for separate businesses. Preservation condition is considered good. This building is considered potentially eligible for nomination to the *NRHP* under *Criterion A* due to its association with the development of local transportation and commerce. The building is considered potentially eligible for the Alabama Register based on antiquity, overall preservation condition, and its contribution to the historic setting of Downtown Troy.

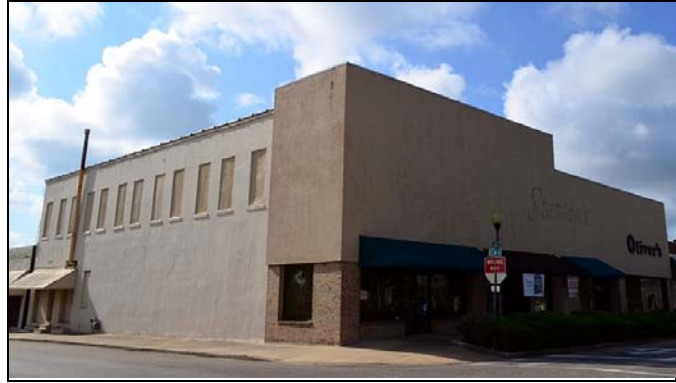
Figure 4.10. Southeast view of Stanton's I and II.

This two-story commercial vernacular building has been substantially altered on the western elevation facing Court Square (Figures 4.10, 4.11). Street level alterations have replaced historic details with modern brick and display windows and doors. Second story windows on Court Square have been covered over by modern alterations. Upper story windows on Elm Street have been bricked over. A secondary entrance located on Elm Street provides second floor access. Preservation condition is considered moderate.

This building is considered potentially eligible for nomination to the *NRHP* under *Criterion A* due to historical associations with the Parker House hotel, and for the Alabama Register based on antiquity and contribution to the historic character of Downtown Troy. Future alterations should consider exposing second floor windows and parapet on the Court Square facade.

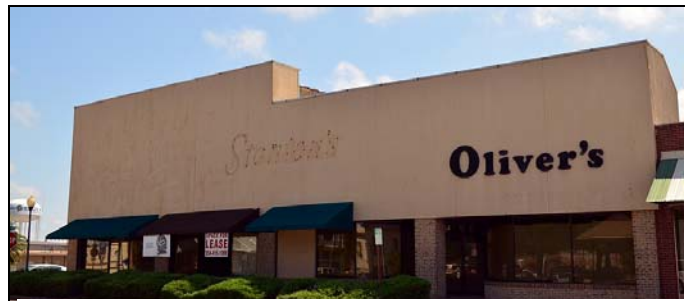
Figure 4.11. West elevations at Stanton's I and Stanton's II (Oliver's).

This two story commercial vernacular building has been significantly altered on the Court Square facade (Figure 4.11). All historic elements within the front facade have been obscured by modern renovations. Preservation condition is moderate.

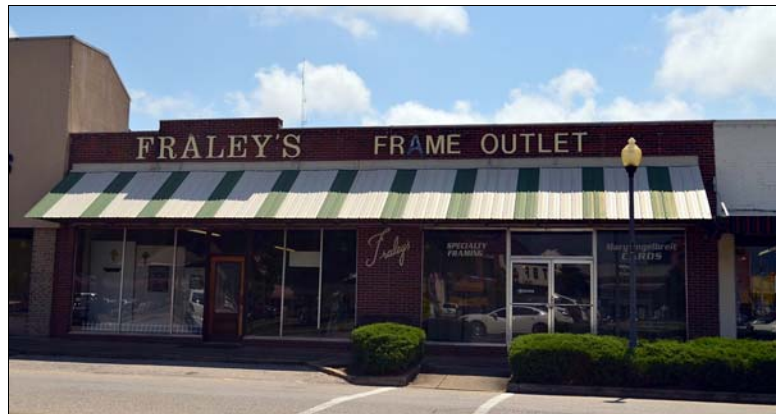
This one-story commercial vernacular building has been altered with modern display windows and door (Figure 4.12). The upper half of the entrance facade retains a parapet that has been covered in aluminum siding. Listed construction date is 1900.

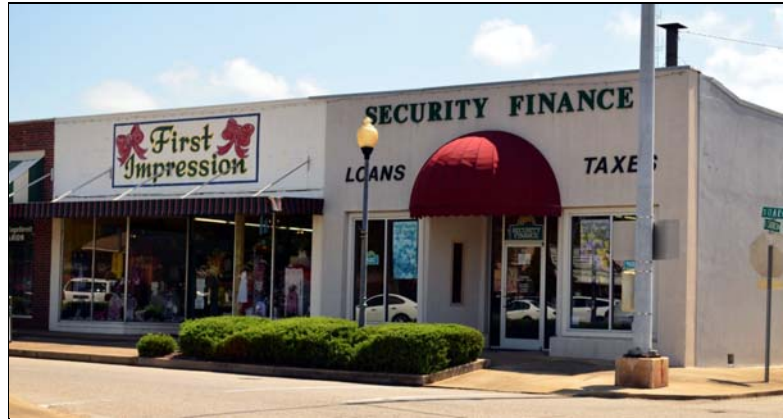
Figure 4.13. First Impression and Security Finance buildings, west elevation.

This one-story commercial vernacular building has been altered with modern display windows (Figure 4.13), but retains a double wooden door with plain transom light. The upper half of the entrance facade retains a painted parapet with obscured brick. Listed construction date is 1900.

This building is considered ineligible for nomination to the *NRHP* due to modern alterations. This building is considered potentially eligible for the Alabama Register based on antiquity, overall preservation condition, and its contribution to the historic setting of Downtown Troy. Future alterations should incorporate more historically appropriate materials in order to improve the historic character of the front elevation.

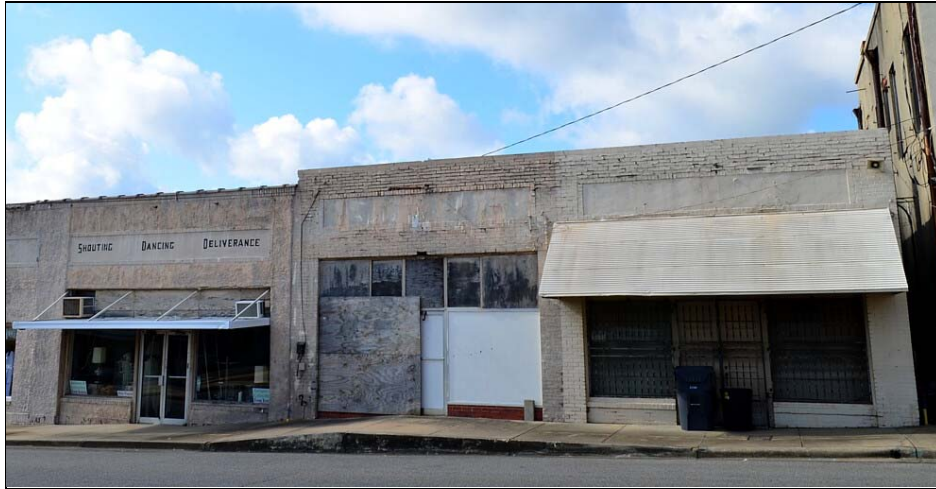
Figure 4.14. North elevations at 14-60a, 14-60b, and 14-59a (right to left).

Buildings 14-60a, 14-60b, and 14-59a are considered ineligible for nomination to the *NRHP* due to dilapidated conditions and modern alterations. These buildings are considered potentially eligible for the Alabama Register based on antiquity, and for their collective

contribution to the historic setting of Downtown Troy. Future alterations should incorporate more historically appropriate materials in order to improve the historic character of the front elevation. Preservation condition is considered very poor.

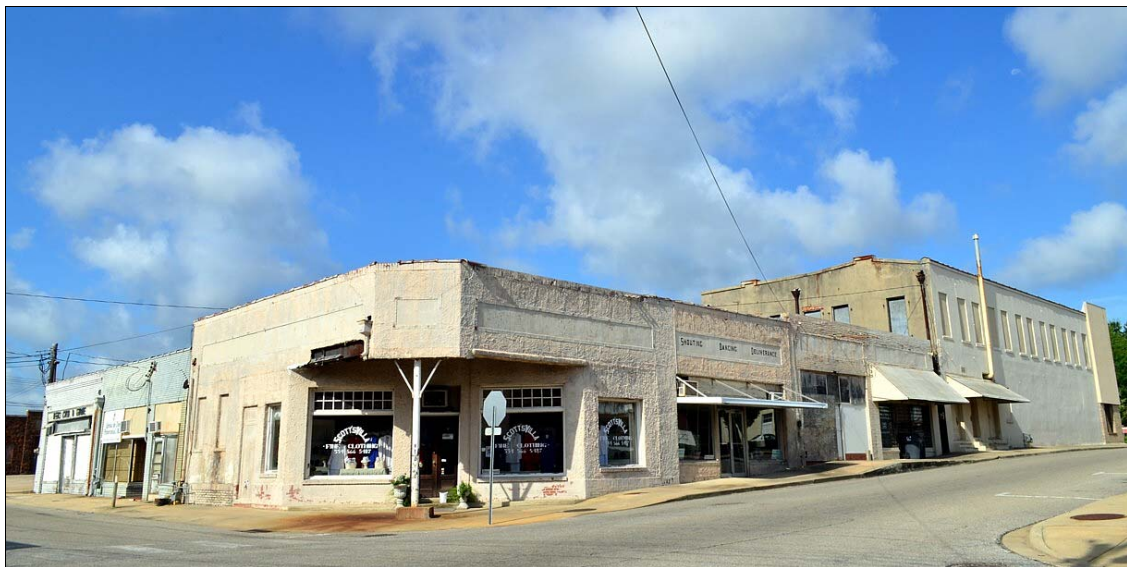
Figure 4.15. Northeast corner of Block 14 with 14.59b in foreground.

This one story commercial vernacular building is particularly significant in that it represents one of only two surviving corner entrance facade buildings in Downtown Troy (see O'Neil Motor Company building, 10-40). The corner entrance consists of double wooden doors with enclosed transom light flanked by two display windows with eight-over-eight fixed transom lights (Figure 4.15). An alternate single door entrance on the Market Street facade has been closed up with concrete. The property appraisers listed construction date is 1920. Interior and exterior preservation condition is considered very poor.

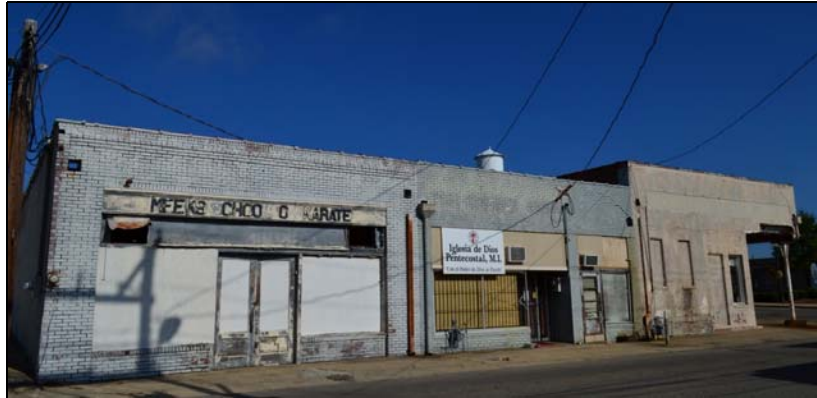
Figure 4.16. East elevations at 14.59b, 14.59c, and 14.59d.

This one story commercial vernacular building contains a primary storefront with single wooden entry door flanked on the left by a modern display window (Figure 4.16). A small secondary storefront on the right of the building contains a wooden door with a plywood covered display window. Transom lights spanning the entire facade are covered with plywood. The building does retain what appears to be original street level brick and brick parapet. The property appraisers listed construction date is 1920. Interior and exterior preservation condition is considered very poor.

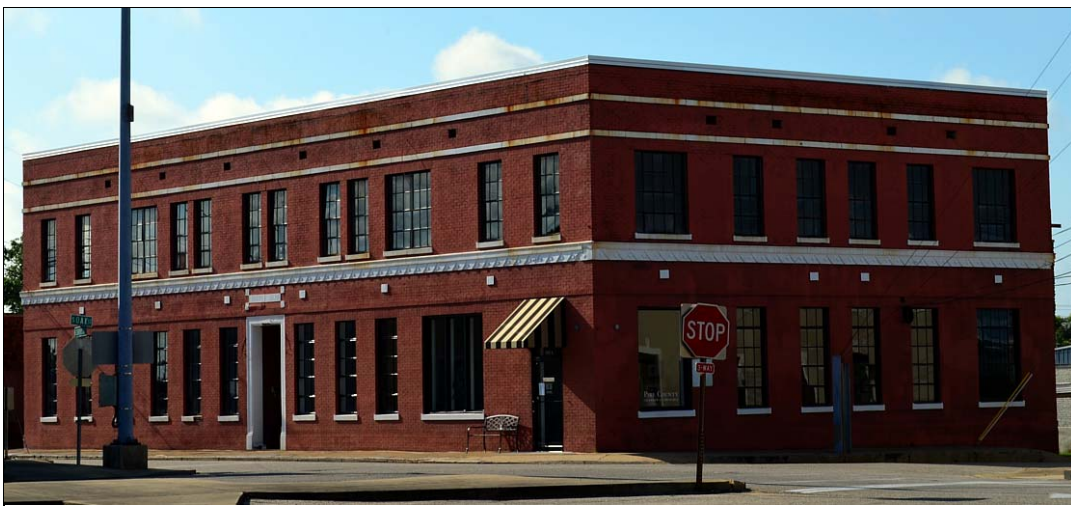
Figure 4.17. Carroll Building, northwest oblique.

The Carroll Building is a two story commercial vernacular structure with Georgian elements (Figure 4.17). The property appraisers' listed date is 1900. However, an earlier building at this location was almost destroyed during the 1934 fire. Decorative elements and salvaged brick from the earlier building appear to have been salvaged for constructing the Carroll Building. Surviving parapet details and the number and composition of windows and doors differ from attributes depicted in historic photographs (Figure 2.2, 2.3). Exposed second floor rafters and brick show evidence damage from a fire that occurred after the 1934 reconstruction. Further research is necessary to narrow the construction date for this building. Preservation is currently good and improving with ongoing maintenance to the building's interior.

A first floor cornice with sawtooth molding spans the west and north elevations. A series of decorative white blocks created by painted brick soldiering are located below the first floor cornice on the north and west elevations. Parallel bands of plain concrete molding with interior wall vents span the north and west elevations above second story windows. A plain parapet with aluminum coping tops the north and west roof lines. The south and east elevations contain window compositions similar to other elevations, but lack decorative details.

The Carroll Building is considered potentially eligible for nomination to the *NRHP* under *Criteria A* and *C*, and for the Alabama Register based on antiquity and architectural attributes. This building is a strong contributing property to the historic character of Downtown Troy.

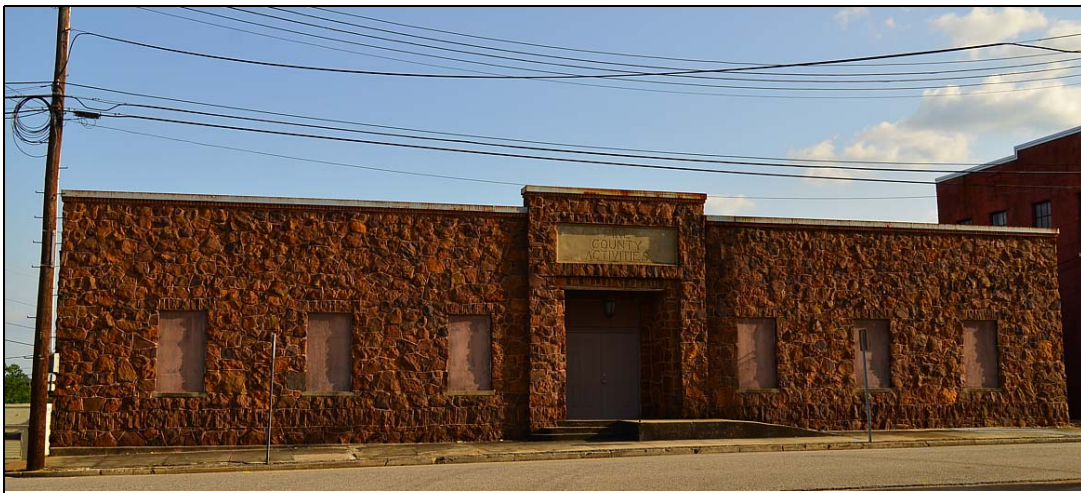
Figure 4.18. North elevation at the Rock Building.

The Rock Building was built using native ironstone gathered from all over Pike County by local residents (Figure 4.18). This building is considered representative of the community spirit of Pike County during the Depression era. Originally designated the Pike Activities Building, this public vernacular style building was constructed as a WPA project in 1938-1939 and consists of two stories, with the first floor semi-subterranean in the southern portion of the building. A previous building at this location was destroyed during the 1934 fire.

The first floor served as a community meeting area and contains an elevated wooden stage in the north of the building. The majority of the first floor contains a concrete surface. Pooled water from stormwater leakage was present at the time of this survey. A central room that served as ticket collection station and movie projector room is located underneath the stairway. Restroom facilities and office space are located in the southeast corner of this floor, while the boiler room is located in the northwest corner.

The Rock Building is considered potentially eligible for nomination to the *NRHP* under *Criteria A* and *C*, and for the Alabama Register based on antiquity and architectural attributes. This building is a strong contributing property to the historic character of Downtown Troy. Average preservation condition is moderate to poor. Increased attention should be given to protecting and rehabilitating this important Pike County landmark.

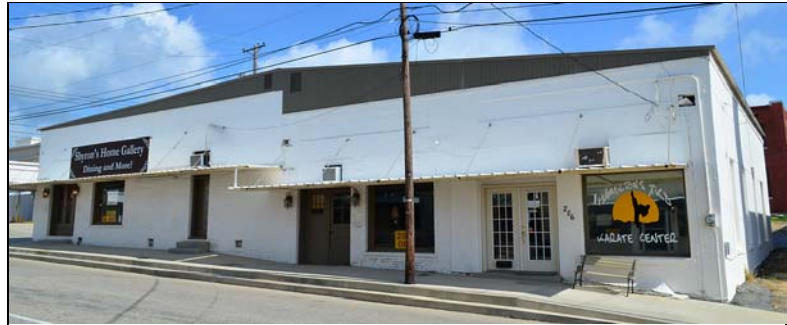
Figure 4.19. South elevation at Sharon's II.

This commercial vernacular building (Figures 4.19) was constructed in 1934. An earlier building at this location was destroyed in the 1934 fire. Modern alterations to the roof have obscured a significant amount of exterior fabric, but existing doors and windows may be associated with the original construction. Preservation condition is considered good.

This building is not considered eligible for *NRHP* nomination due to contemporary alterations, but is potentially eligible for nomination to the Alabama Register based on antiquity and contributions to the historic setting of Downtown Troy.

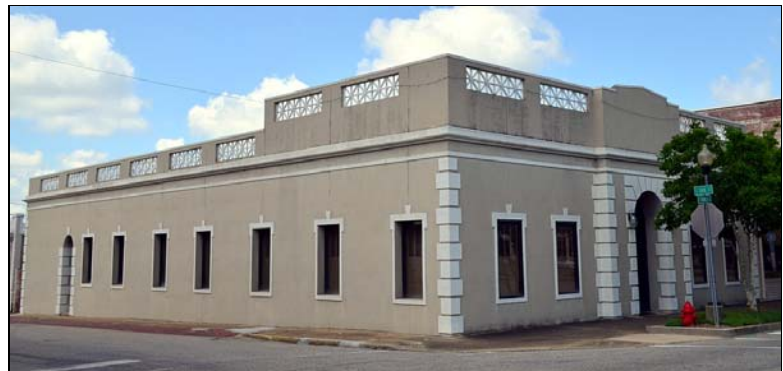
Figure 4.20. Northeast oblique at 18-24.

This one story commercial vernacular building retains elements associated with an earlier two story structure that was in existence as late as 1934 (see 1934 fire pics). The listed construction date is 1945. Local informants state that this building was damaged by fire in the 1970's and rebuilt as a modern one-story version designed to resemble the original structure. Parapet decorations appear to have been recycled from the original building (Figure 4.20). This building does not meet the antiquity criteria for nomination to the *NRHP* and the Alabama Register.

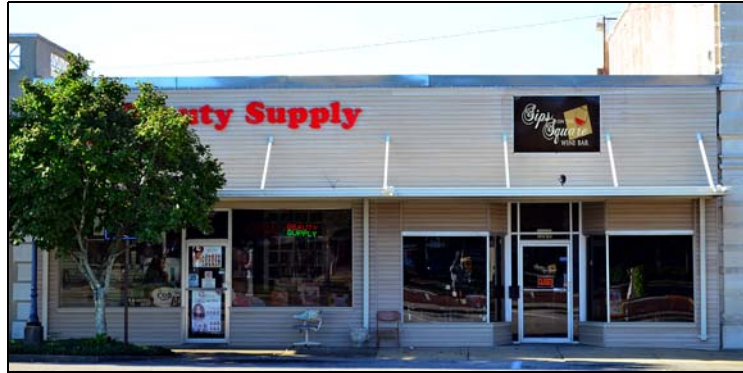
Figure 4.21. South elevation at 18-24 and 18-25.

This one-story commercial vernacular building has been altered with modern display windows and door (Figure 4.21). All structural elements of the Court Square facade (including parapet) have been covered in aluminum siding. Listed construction date is 1900.

This building is considered ineligible for nomination to the *NRHP* due to modern alterations. This building is considered potentially eligible for the Alabama Register based on antiquity, overall preservation condition, and its contribution to the historic setting of Downtown Troy. Future alterations should incorporate more historically appropriate materials. Removal of aluminum siding would markedly improve the overall historic character of the front elevation.

This building is considered ineligible for the *NRHP* due to modern alterations. This building is considered potentially eligible for the Alabama Register based on antiquity, overall preservation condition, and its contribution to the historic setting of Downtown Troy. Future alterations should incorporate more historically appropriate materials. Removal of aluminum siding would markedly improve the overall historic character of the front elevation.

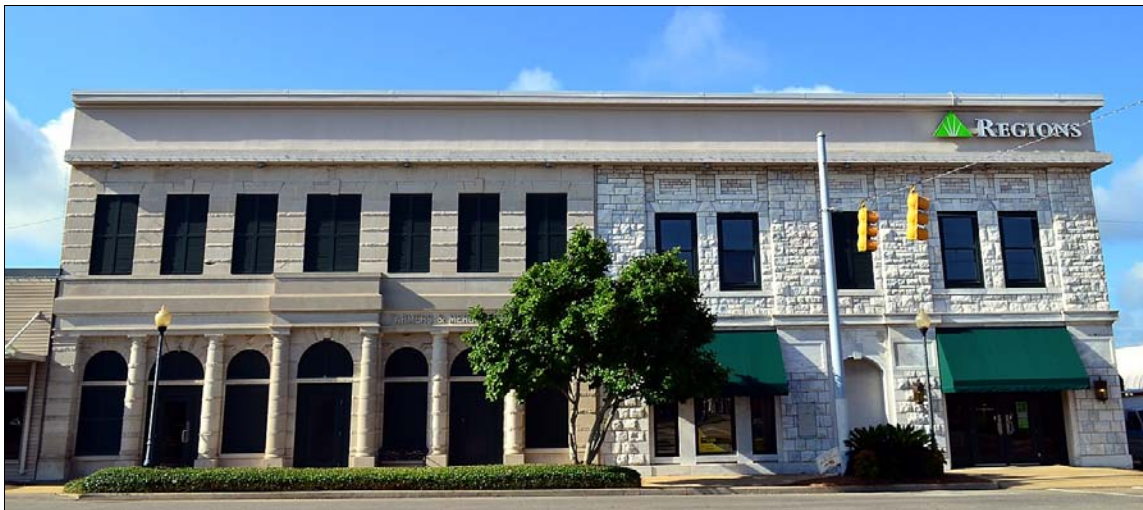
Figure 4.22. North elevation at F&M building (left) and Telephone Exchange building

This ca. 1900 building has been repeatedly altered with changes in access door style and location. Window types and layouts have also been changed over time. The exterior fabric with six engaged columns retains Classical Revival elements on the Court Square (Figure 4.22). However, the most dramatic alteration has been the covering and/or removal of the Greek Revival pediment and parapet that once capped the Court Square facade. The building contains an historic bank vault within the basement that may be the original Farmers and Merchants Bank vault.

This ca. 1890 building has been repeatedly altered with changes in access door style and location (Figure 4.22). The original rough-cut stone exterior fabric appears unaltered, but window types and layouts have been changed over time. The most dramatic alteration has been the covering and/or removal of the stone parapet that once topped the Court Square facade.

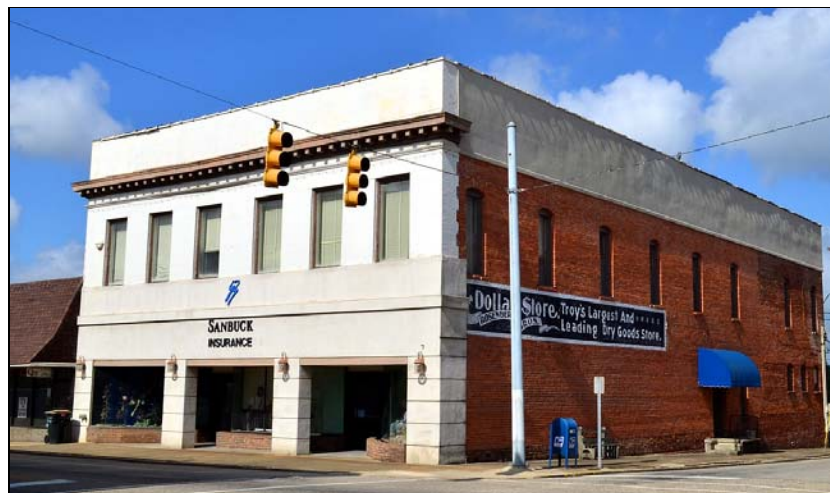
Figure 4.23. Rosenberg Building, northeast oblique.

This building is first depicted as a two story structure on the 1931(4) Sanborn map, but not reference to business is provided. The front elevation has been altered on first floor level, with second floor retaining majority of historic fabric. Dentil molding spans the front elevation above the second floor windows, which have been reinforced with structural glass on all sides.

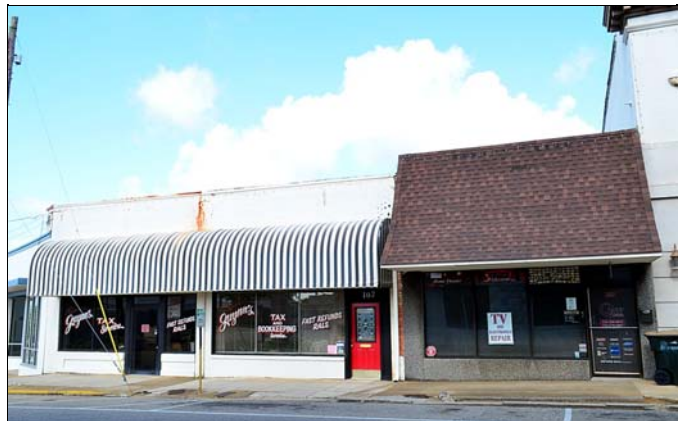
Figure 4.24. QEW, Guynns 1 and 2 (right to left), west elevation.

This one-story commercial vernacular building has been altered with modern display windows and door, as well as a pebbled exterior fabric at street level (Figure 4.24). Any surviving parapet features have been obscured by a modern shingled storefront. Listed construction date is 1900.

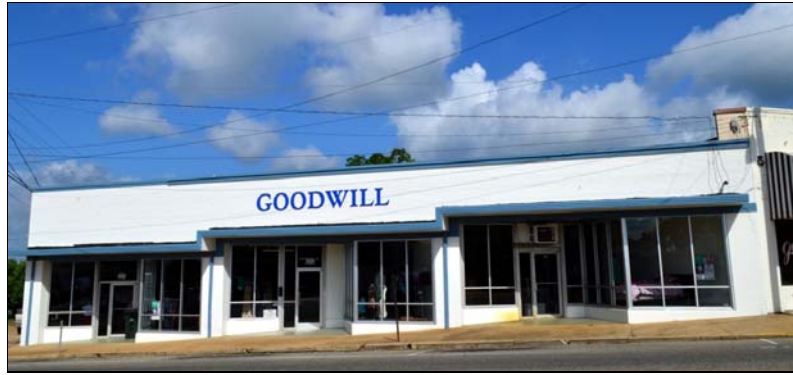
Figure 4.25. Goodwill complex, 16a-19.01, 19, and 20.02 (right to left).

This one-story commercial vernacular building has been altered at street level with modern display windows and door (Figure 4.25). The building is designed to account for the southward slope within this portion of 3-Notch Street, and contains three separate storefronts that retain interior wall divisions. The parapet level appears to retain original brick elements. Listed construction date is 1900. Preservation condition is considered good.

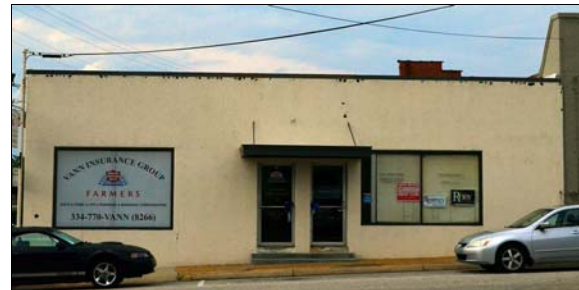
Figure 4.26. Vann Insurance Building, south elevation.

This one story commercial vernacular building is not depicted on available Sanborn maps up to 1931, indicating a post 1931 construction date. The building has a painted stucco over brick exterior and updated windows and doors (Figure 4.26). A plain parapet with coping surrounds the roof.

This building is considered ineligible for nomination to the *NRHP*, but is potentially eligible for the Alabama Register based on antiquity and its contribution to the historic setting of Downtown Troy.

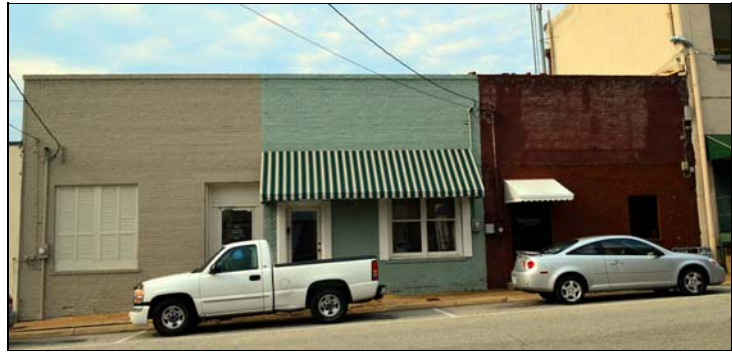
Figure 4.27. South elevation at buildings 13-10.03, 10.02, and 10.01 (left to right).

This simple one story commercial vernacular structure has been updated with a modern double hung sash window and wood framed door (Figure 4.27). The external fabric consists of painted brick. A decorative pilaster surrounding the door appears to be a relatively modern alteration. Preservation condition appears to be good. This building is considered ineligible for nomination to the *NRHP*, and is potentially eligible for the Alabama Register based on antiquity and its contribution to the historic setting of Downtown Troy.

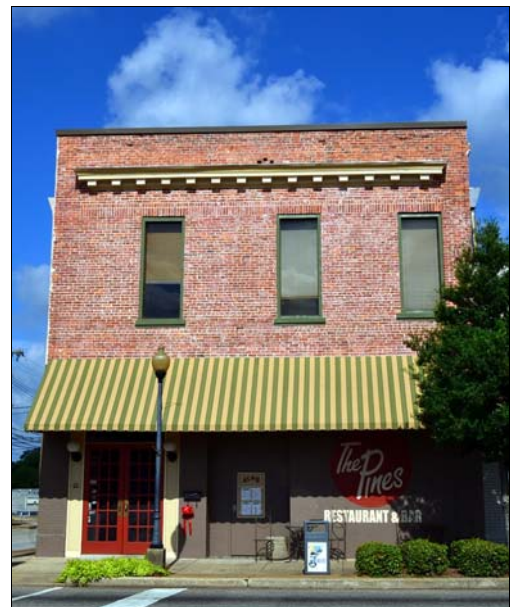
Figure 4.28. The Pines Building, east elevation.

The east elevation contains the main entrance consisting of modern French doors. A secondary front entry door provides access to the second floor staircase. The second floor of the front facade retains three windows with single pane structural glass. Dentil molding spans the front elevation. A simple parapet with plain coping surrounds the roof. Second floor windows updated with single pane structural glass are present along the second floor on the south elevation. Listed construction date is 1900, although

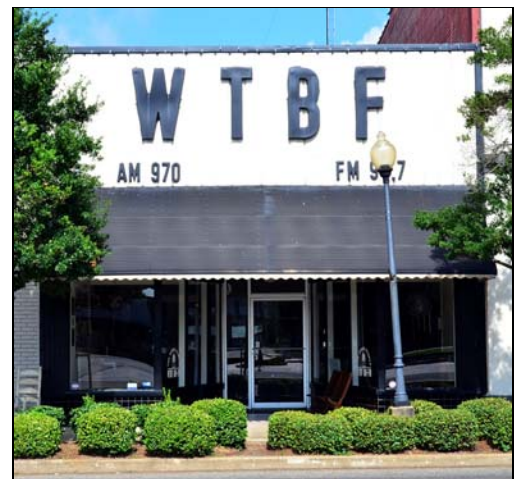
Figure 4.30. WTBF Building, east elevation.

This one story commercial vernacular building is unique in that it retains street level elements with 1950's details. (Figure 4.30). Black tile and tile mosaic flank the glass/metal display windows and doors, all of which are shaded by a black aluminum awning. An exterior tile floor entrance contains the original “Harvey’s” wording associated with historic use as a department store. The upper level parapet has been covered with siding and plain black aluminum coping.

This building is considered potentially eligible for *NRHP* nomination under *Criteria A* and *C*, and is also potentially eligible for nomination to the Alabama Register due to antiquity and contributions to the historic setting of Downtown Troy. This building serves as a landmark historic structure on Court Square.

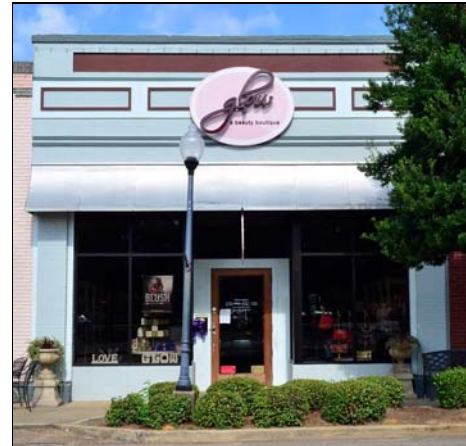
Figure 4.33. 13-64, Glow, east elevation.

This one story commercial vernacular building has been updated at street level with structural glass display windows and transom lights (Figure 4.33). A wooden door with covered sidelights is present under a contemporary aluminum awning. A decorative parapet with brick molding and paneling tops the front elevation. Preservation condition is considered good.

This building is considered potentially eligible for *NRHP* nomination under *Criteria A* and *C*, and is also potentially eligible for nomination to the Alabama Register based on antiquity and contributions to the historic setting of Downtown Troy. This building serves as a landmark historic structure on Court Square.

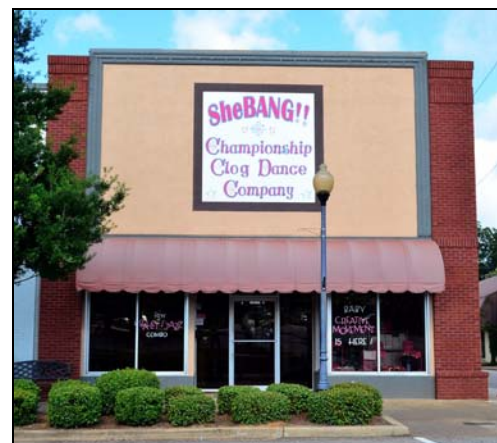
Figure 4.34. 13-63, SheBang, east elevation.

This one story commercial vernacular building has been updated at street level with structural glass display windows, door, sidelights and transom lights (Figure 4.34). A plastered parapet with painted signage tops the front elevation. Preservation condition is considered good. This building contains 13-63.01, which has been subdivided off main building in rear.

This building is considered potentially eligible for *NRHP* nomination under *Criteria A*, and is also potentially eligible for nomination to the Alabama Register based on antiquity and contributions to the historic setting of Downtown Troy. This building serves as a landmark historic structure on Court Square.

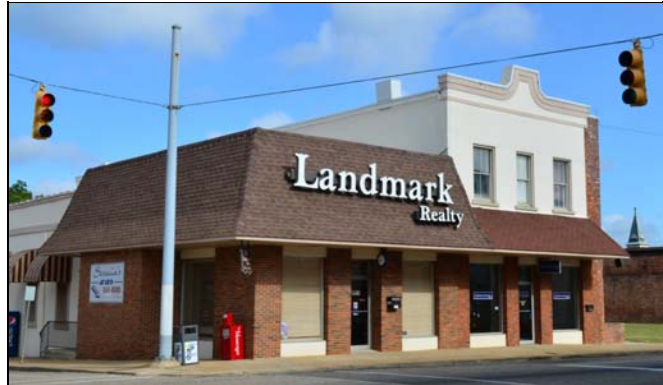
Figure 4.35. Landmark I and II, southeast oblique.

This one story building has been substantially altered with modern brick, display windows and door (Figure 4.35). A shingled roof extension covers any remaining historic parapet details. A basement level component contains a barber shop. It is interesting to note that the 1885 Sanborn map (1) depicts a barber shop in the basement of this same building.

This two story commercial vernacular building has been substantially altered at street level by the addition of modern brick, display windows and door (Figure 4.35). The second floor level appears to retain some degree of historic fabric in the surviving windows. Historic photographs indicate that original parapet details largely remain, with the exception of a large stylized crucible and pestle that historically adorned the parapet peak during this building's tenure as a drug store. The property appraiser's listed construction date is 1900. However, this building is depicted as a two-story drug store in 1885 (Sanborn:2). Preservation condition is considered good.

This building is considered ineligible for nomination to the *NRHP* due to modern alterations. This building is not a strong candidate for the nomination to the Alabama Register due to street level alterations, but the presence of the basement level barber shop dating to at least 1885 is historically significant.

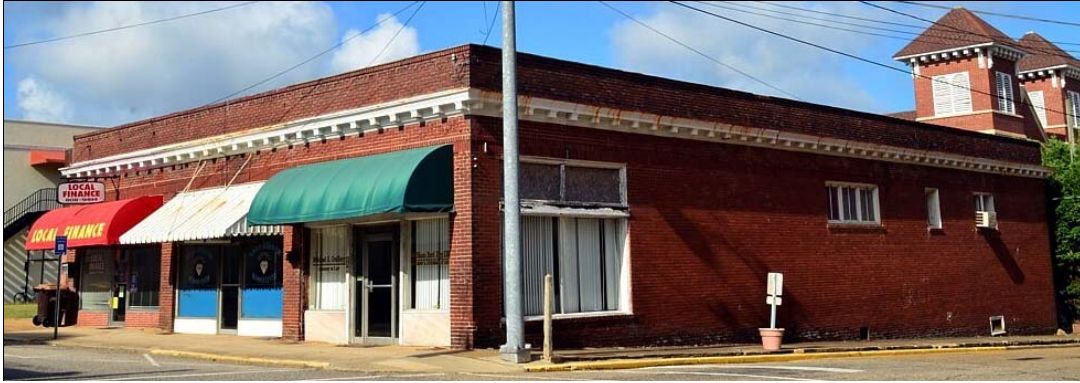
Figure 4.36. Northeast oblique at 12-23, 12-24, and 12-25 (left to right).

The surviving building retains three distinct storefronts. Dentil molding spans the east and north elevations under a simple parapet with plain coping (Figure 4.36). Each storefront has been updated with modern display windows and doors. A single wood trimmed display window with plywood covered transom light is located on the north elevation, along with a set

of three wood trimmed, vertical paned, hopper windows. Two small, wood trimmed, fixed windows are located on the western portion of the north elevation. Preservation condition appears to be good.

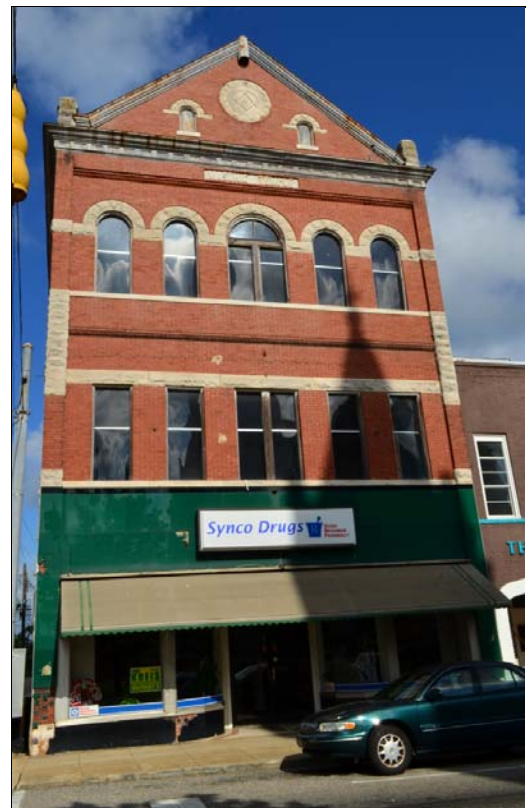
Figure 4.37. Masonic Building, east elevation.

The three and a half story Masonic Building features the Richardsonian Romanesque style (Figure 4.35). The dominate feature of this style, the Romanesque arch, is featured in the windows of the third story and above in the pediment of the façade. Other classic features of this popular 19th century style

are evidenced in the belt course of rough faced ashlar and semicircular window arches that spring from a heavy wall surface. A decorative egg and dart motif in terra cotta runs several feet above the belt course. The building's composition is representative of the two-part commercial block as the façade is horizontally divided into two distinct zones.

The east façade is covered with two types of pressed, red brick and highlighted on the corners with rough faced ashlar quoins. The first story is sheathed in pigmented structural glass that was probably added in the 1930s or 1940s. At that time, the first story façade also appears to have been altered with the addition of large, commercial window glazing separated by thick aluminum mullions. The colored terrazzo flooring at the recessed entrance is in keeping with that period too. The scalloped aluminum awning is a later addition as well. The glass double doors are contemporary.

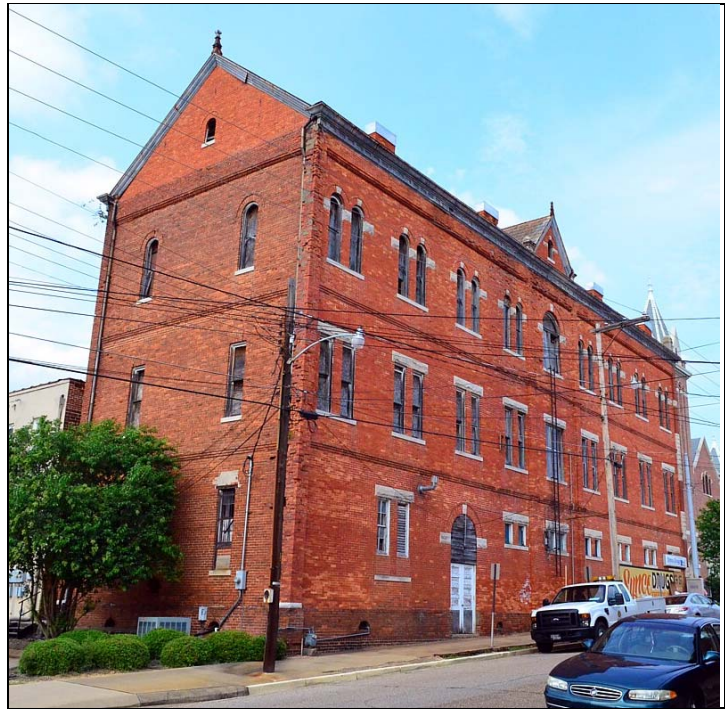
Figure 4.39. Masonic Building, southwest oblique.

The south elevation features numerous windows in double groupings that retain their original wood sashes. The first story has six pairs of small square windows with thick, rough faced stone lintels, thinner smooth sills and single pane sash. One pair of the windows is rectangular, double hung sash, and were partially bricked in at a later date. The second story windows are all rectangular, double hung sash with single panes in each sash. They are capped with rough faced stone lintels and thinner smooth sills below. The center pair is grouped closer together and is divided by a wood mullion. The third story windows are all semicircular arched, double hung sash with single panes in each sash. The original rounded wood muntins are still present in a few of these windows. They are capped with keystones and thinner smooth sills below. The center window pair features a semicircular transom and wood mullions. The center

windows on all three stories are flanked by two pilasters that run the entire length of the elevation, located just below the dormer.

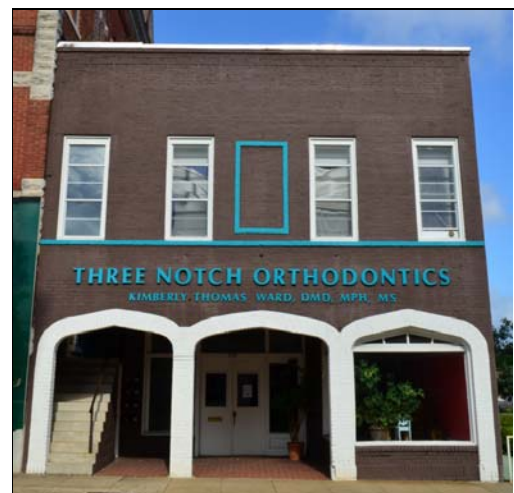
Figure 4.40. 5-14, Ward Building, east elevation.

This two story commercial vernacular building is first depicted on Sanborn maps in 1931 (2). The first story has an arcade entrance formed by four brick columns supporting brick Tudor arches (Figure 4.40). Double wood paneled doors bordered by large single pane transom lights form the main entrance. The right bay of the entrance facade is framed with wood trimmed display glass windows that enclose a front display window gallery. Rectangular brick molding for painted signage is located at the center of the second story front elevation. Four second story windows above the string course have been updated with aluminum framed, double hung sash windows with fixed transom lights under lintels of soldiered brick. Similar windows are located on the north and west elevations.

A plain brick parapet with aluminum coping surrounds the roof. An open stairwell provides access to the second floor of the adjacent Masonic building.

This building is considered potentially eligible for nomination to the *NRHP* under *Criteria A and C*, and for the Alabama Register under comparable

criteria. This building is a strong contributing property to the historic character of Downtown Troy.

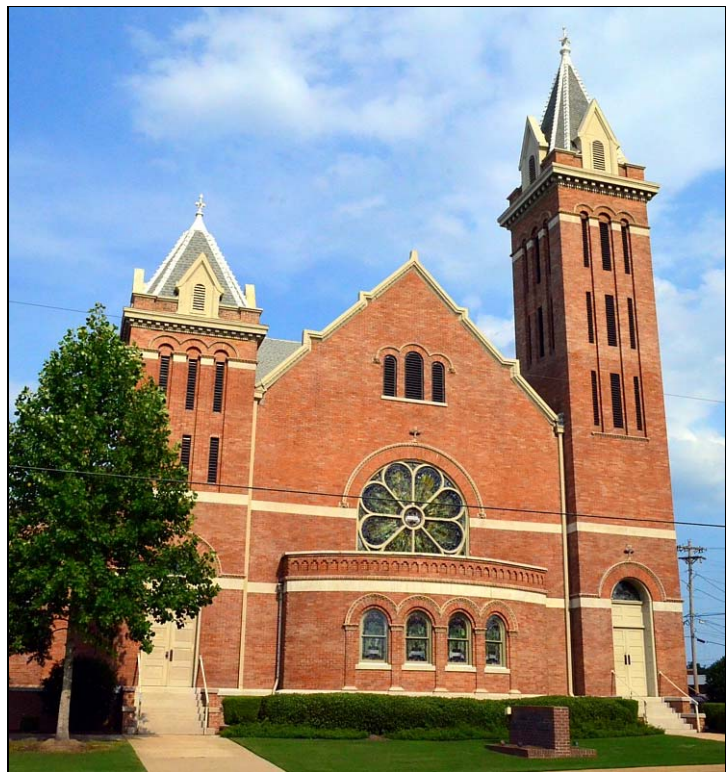
Figure 4.41. Methodist Church, west elevation.

Constructed in 1904, the First United Methodist Church illustrates a composite of two popular 19th century styles; a sacred form of the Richardsonian Romanesque style and the Gothic Revival style (Figure 4.41). The majority of the structure represents the Richardsonian Romanesque, with some details reflecting the Gothic Revival style. The north elevation features two bell towers, one higher than the other, forming an asymmetrical façade. The higher tower with a more steeply pitched roof gives the effect of a campanile. Both towers have paneled double door entrances with stairs leading up to them at the base, and semicircular arched, stained glass transoms above. The transoms have arch surrounds in brick and masonry above, topped by foliated masonry finials in the center. Both towers have louvered vents set between brick pilasters, culminating in three smaller, semicircular arches on all four sides. The grouping of these elements forms an elongated blind arcade. The arches spring from a thick, broken belt course. Heavy cornices with decorative dentil moldings lie just above the arches. Each tower features a steeply pitched, hipped roof covered in slate shingles with decorative flashing and topped with foliated finials. All four sides have parapeted gables reflecting the steep lines of the roof, with semicircular arched louvered roof vents (rather than lucarne) set in them.

The bell towers flank the center portion of the church that has a large, stained glass rose window in the center. This window breaks a belt course that runs the width of the façade. The rose window is highlighted by a semicircular arch, it's surround in brick and masonry with a foliated finial at the top. Just below the rose window is a bowed wall with a ribbon of smaller, arched, stained glass windows. These double hung sash windows are set on smooth masonry sills. The semicircular stilted arches above these windows spring from brick pilasters that are highlighted with masonry bases and capitals. The arches are topped with decorative masonry surrounds. Corbel tables are present above the belt course within this bowed wall.

Above the rose window within the center of the gable are three arched openings with louvered vents. Above them are masonry arch

surrounds with a shared masonry sill below. The brick wall surface extends up into the gable without a break, typical of the Gothic Revival style. The roof form is cross gabled with a moderate pitch. The roof-wall junction is highlighted by a cornice with two points of varying size on each side of the pitch, creating a small parapet.

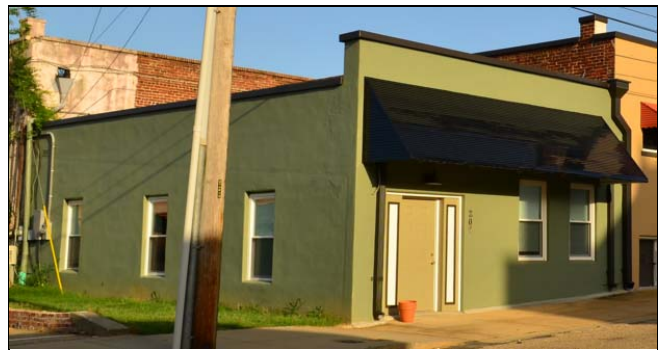
Figure 4.42. 7-11.1, northwest oblique.

This one-story commercial vernacular building faces Oak Street and appear to retain a majority of external historic fabric, with the exception of the addition of modern windows and door (Figure 4.42). Door side light elements have been retained, but enclosed. Construction date is post-1931 (Sanborn 1931:3).

This building is considered ineligible for *NRHP* nomination, but is potentially eligible for the Alabama Register based on antiquity, retention of a moderate level of historic fabric, and its contribution to the historic setting of Downtown Troy. Preservation condition is considered good.
