Deer Stand Hill: An Architectural Survey
of Historic Buildings in Downtown Troy, Alabama

prepared for
The Pike County Chamber of Commerce, Inc.
101A East Church Street
Troy, Alabama 36081

by
Laura Lee Corbett
and
Tray G. Earnest, RPA
TG. Earnest & Associates, LLC
511 2nd Avenue
Troy, Alabama 36081

September 26, 2012

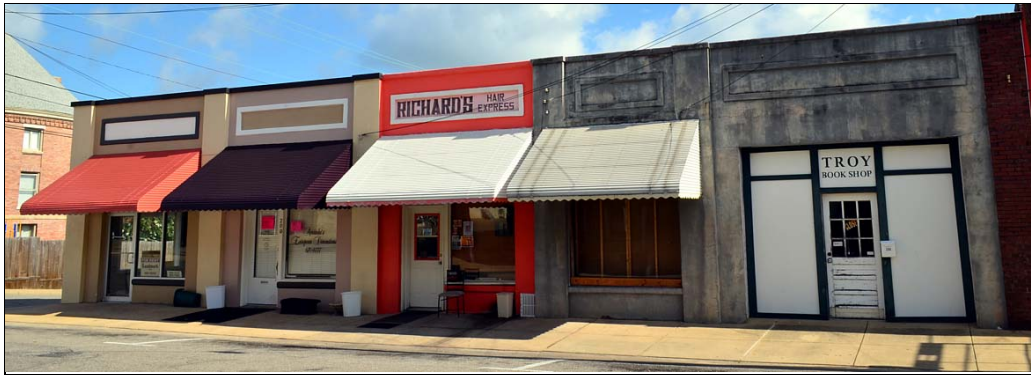
Figure 4.43. 7-11.4a, 11.4b, 11.2, and 11 (left to right), south elevations.

This one-story commercial vernacular building has been altered at street level with modern display windows and door (Figure 4.43). An upper paneled parapet is formed by brick molding. An aluminum awning shades the front elevation. Construction date is post-1931 (Sanborn 1931:3). Preservation condition is considered good.

This one-story commercial vernacular building has been altered at street level with modern display windows and door (Figure 4.43). An upper paneled parapet is formed by brick molding.

This one-story commercial vernacular building has been altered at street level with modern display windows and door (Figure 4.43). An upper paneled parapet is formed by brick molding surrounding painted signage. An aluminum awning shades the front elevation. Construction date is post-1931 (Sanborn 1931:3).

This one-story commercial vernacular building has been altered at street level plywood covered display windows and a contemporary wooden door (Figure 4.43). A paneled parapet with brick coping tops the building's front elevation. An aluminum awning shades a shuttered display window. External fabric is plaster over brick. Construction date is post-1931 (Sanborn 1931:3).

This building is considered ineligible for *NRHP* nomination, but is potentially eligible for the Alabama Register based on antiquity, retention of a moderate level of historic fabric, and its

contribution to the historic setting of Downtown Troy. Preservation condition is considered good.

This building is considered ineligible for *NRHP* nomination, but is potentially eligible for the Alabama Register based on antiquity, retention of a moderate level of historic fabric, and its contribution to the historic setting of Downtown Troy. Preservation condition is considered good.

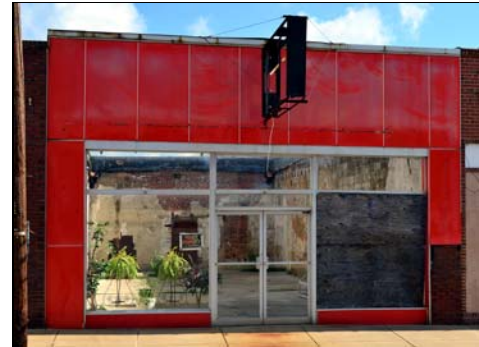
Figure 4.44. Building 7-10, south elevation.

The 1916 (4) Sanborn map depicts a sausage manufacturing business with ‘2 ton ice machine’. What remains of this building represents the oldest surviving structure on Block 7. This building, unfortunately, is extremely poor condition. The front elevation consists of glass/metal display windows and doors (Figure 4.44). The majority of internal architectural elements and the roof of this building are no longer present. Motor components associated with the historic ice machine appear to be visible toward the rear of the building.

This building is considered ineligible for *NRHP* nomination and for the Alabama Register due to dilapidated conditions. Preservation condition is considered extremely poor.

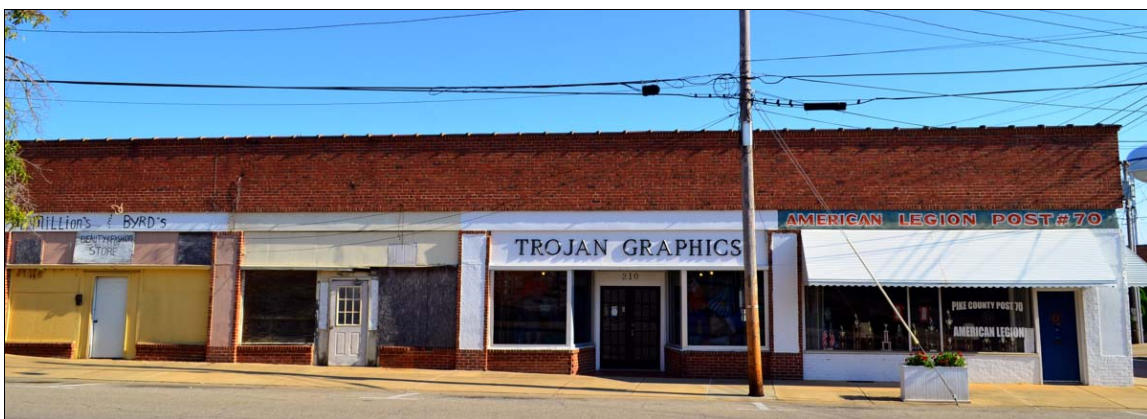
Figure 4.45. American Legion Building, south elevation.

Buildings 7-9a, 7-9b, 7-9.2 and 7-9.1 are each under separate ownership, but should be classified as separate storefronts within the same building (Figure 4.45). These storefronts are connected under a shared parapet, and are depicted on the 1931(3) Sanborn map as being separate divisions within one building. Subdivisions within this building vary in preservation condition. 7-9a and 7-9b survive as only a shell of the original storefront, with the roof, floor, and interior attributes lost to time and decay. 7-9.2 appears to be in good condition and survives as an active business, as does 7-9.1 under use by the American Legion.

This building varies greatly in regards to preservation condition. Active storefronts have been updated with modern windows and doors, while vacant sections are in extreme disrepair.

This building is considered ineligible for *NRHP* nomination and for the Alabama Register due to dilapidated conditions. Average preservation condition for the building as a whole is considered extremely poor.

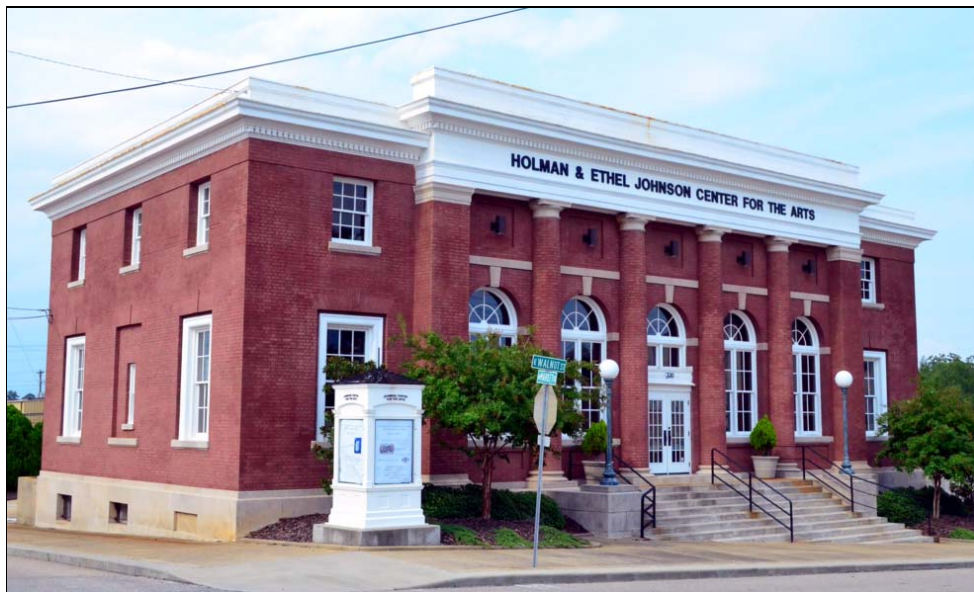
Figure 4.46. Johnson Center (Old Post Office), southwest oblique.

The following text from the historic marker located at the front of the Johnson Center provides a comprehensive description of this building (Figure 4.46):

“The Historic Troy Post Office (Circa 1910). Chiseled in the cornerstone are the words *Franklin MacVeagh, Secretary of the Treasury, James Knox Taylor, Supervising Architect, MCMX*. This Classical Revival-style Post Office remained in service until 1980. The building draws heavily on both Roman and Greek models for its design. It has two stories and a basement; with the main workroom having the full height of the building. The massive revolving door of oak, with brass push plates, was an innovation when the building was first occupied. The building measured 40 by 80 feet on a lot 120 by 100 feet. Parcel post service was instituted all over the country by 1912. In January 1913, *The Messenger* reported that the parcel post business was “good in Troy and is growing by leaps and bounds.” During the first seven days, more than 800 packages arrived in the city. During that same period, there were about 600 packages distributed from Troy by parcel post.

The building has a seven bay front with a closely engaged portico. The portico has two brick pilasters which stand in high relief to the main facade and four engaged modified Doric columns of brick with limestone capitals and bases. Five Palladian arched openings with large keystones fill the space between the

columns, the center opening containing the main entrance doors, the other openings containing double windows, and the brick panel above is paneled as if for five blind windows. The columns are topped by a molded architrave and a wide frieze where the name of the building has been placed. Rising from the frieze is a handsome cornice with compound crown molding and a dentil band. Still on the front facade, the rectangular pilasters are flanked by windows on either side: large sash windows on the lower floor and smaller windows on the second story. Lower than the entrance cornice is a similarly detailed cornice which runs around the top of the entire building. After being renovated in July 2007, the old post office reopened to the public in 2008 as the Johnson Center for the Arts". (Historic Marker, Johnson Center, 2012)

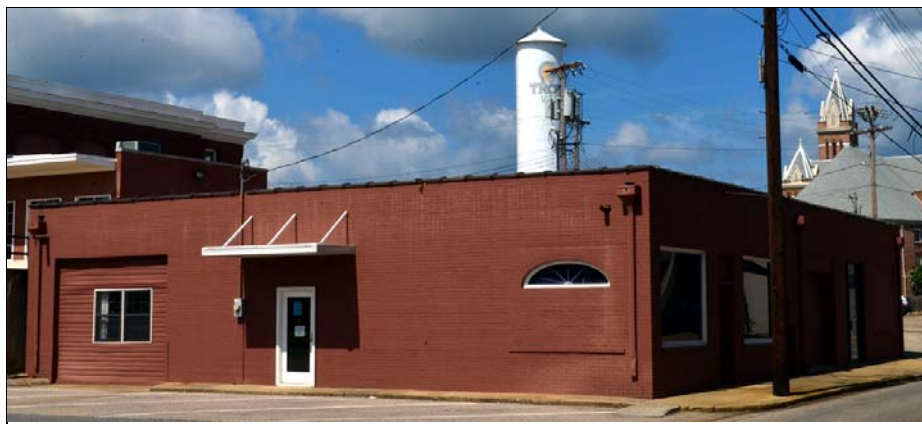
Figure 4.47. Johnson Center Annex, northeast oblique.

This one story commercial vernacular building originally contained both pedestrian and vehicle/freight doors (Figure 4.47). The east and north elevations each contain enclosed entrances. Windows and pedestrian doors have been updated with modern materials. The small fanlight window on the east elevation appears to retain original details. A simple parapet with tile coping surrounds the roof. This building is not depicted on the 1931(3) Sanborn maps, indicating a later construction date.

This building is considered ineligible for *NRHP* nomination, but is potentially eligible for the Alabama Register based on antiquity and its contribution to the historic setting of Downtown

Troy. Preservation condition is considered good.

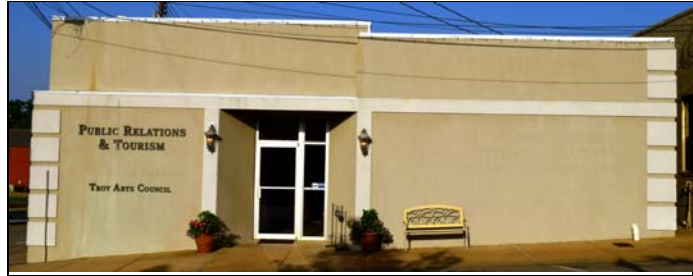
Figure 4.48. Troy Arts Council, west elevation.

This one-story commercial vernacular building has been updated with modern windows and doors (Figure 4.48). Original brick elements and architectural details may be obscured by painted plaster. Listed construction date is 1920, but this building is not depicted on Sanborn maps as late as 1931.

This building is considered ineligible for *NRHP* nomination. Further research is needed to determine Alabama Register eligibility.

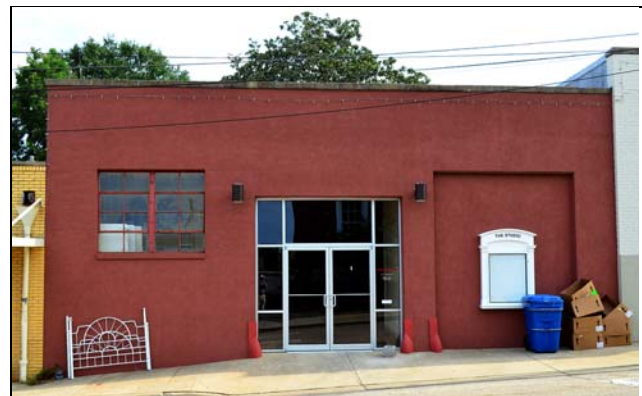
Figure 4.49. Cultural Arts Center, north elevation.

This one-story commercial vernacular building has been updated with modern windows and doors (Figure 4.49). Original brick elements and architectural details may be obscured by painted plaster. Listed construction date is 1920, but this building not depicted on Sanborn maps as late as 1931.

This building is considered ineligible for *NRHP* nomination, but is potentially eligible for the Alabama Register based on antiquity and its contribution to the historic setting of Downtown Troy. Preservation condition is considered good.

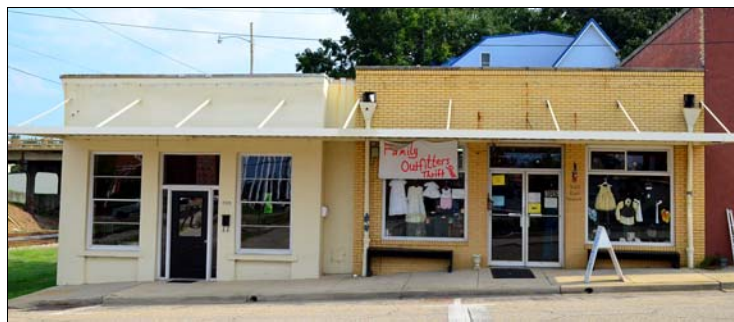
Figure 4.50. Buildings 9-51a and 9-51b (right to left), north elevation.

This one-story commercial vernacular building has been altered with modern windows and doors (Figure 4.50). Double glass/metal doors with fixed transom light are flanked by modern display windows under a simple parapet with plain coping. Property appraiser data indicates a circa 1947 construction date.

This small one story vernacular building first shows up on Sanborn maps in 1916 (4) as a ‘drinks’ store. The current brick structure appears to have replaced an earlier pre-1916 frame building of similar dimensions. The building has been altered with modern windows and doors, within an external fabric consisting of painted plaster over brick (Figure 4.50).

This building is considered ineligible for *NRHP* nomination, but is potentially eligible for the

Alabama Register based on antiquity and its contribution to the historic setting of Downtown Troy. Preservation condition is considered good.

This building is considered ineligible for *NRHP* nomination, but is potentially eligible for the Alabama Register based on antiquity and its contribution to the historic setting of Downtown Troy. Preservation condition is considered good.

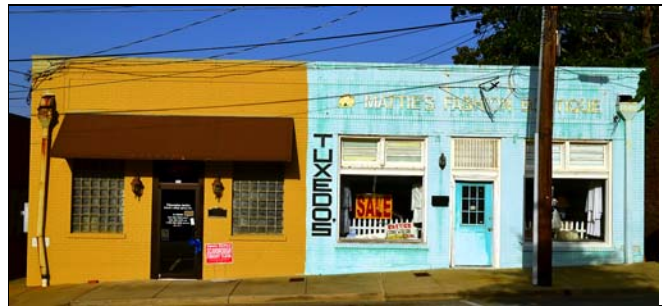
Figure 4.51. West elevation, building 9-49/9-48 (left to right).

This one-story commercial vernacular building could arguably be considered two separate buildings (Figure 4.51). The separate storefronts are connected by the same parapet, but with separate roof lines. Both storefronts have been altered at street level with modern display windows and doors. Building 9-49 exhibits more substantial alterations with glass block windows and a glass/metal door. Building 9-48 appears to retain period correct transom lights. The upper parapet level and street level both appear to retain original brick elements. Listed construction date is 1945.

This building is considered ineligible for individual *NRHP* nomination, but is a potential contributor to an historic district.

The building is also potentially eligible for the Alabama Register based on antiquity, retention of a moderate level of historic fabric, and its contribution to the historic setting of Downtown Troy. Preservation condition is considered good.

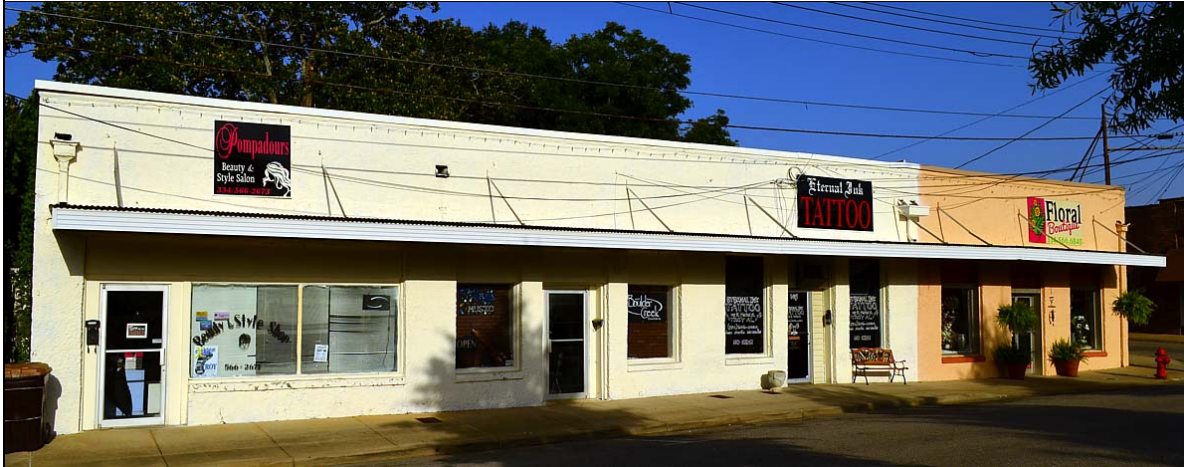
Figure 4.52. West elevation, building 9-47.

This one story commercial vernacular building is divided into four separate storefronts under one owner (Figure 4.52). Each storefront has likely been modified over time with the addition of modern display windows and doors, but the overall building layout and internal divisions appear to correspond to details depicted on the 1916 (4) Sanborn map. This conservative building exhibits limited architectural details, but retains a simple parapet with plain coping. Preservation condition appears to be good.

This building is considered ineligible for *NRHP* nomination, but is potentially eligible for the Alabama Register based on antiquity, retention of a moderate level of historic fabric, and its contribution to the historic setting of Downtown Troy.

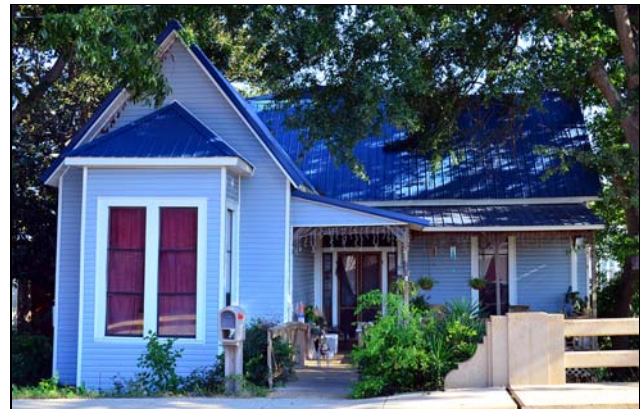
Figure 4.53. South elevation at 9-52, private residence

This one story frame vernacular building is listed in the property appraiser records as constructed in 186, but is not depicted on Sanborn maps until 1891(1). The balloon frame residence has a cross-gabled plan that forms a “T” and represents a gable front and wing form of Folk Victorian common in the southern states (Figure 4.53). The gable end is steeply pitched with a painted, crimped metal roof. The primary entrance under a shed porch faces Elm Street and consists of a single wood paneled door behind double screen doors with surrounding transom and sidelights. The matching shed porch on the north elevation has been enclosed. The windows are contemporary and double hung sash. The south façade features a bay window with a hipped roof within the projecting gable. The entire exterior of the structure is clad with aluminum siding running horizontally. The building appears to retain a moderate level of level of historic fabric. Preservation condition appears to be good.

This building is considered ineligible for *NRHP* nomination, but is potentially eligible for the Alabama Register based on antiquity and for its contribution to the historic setting of Downtown Troy.

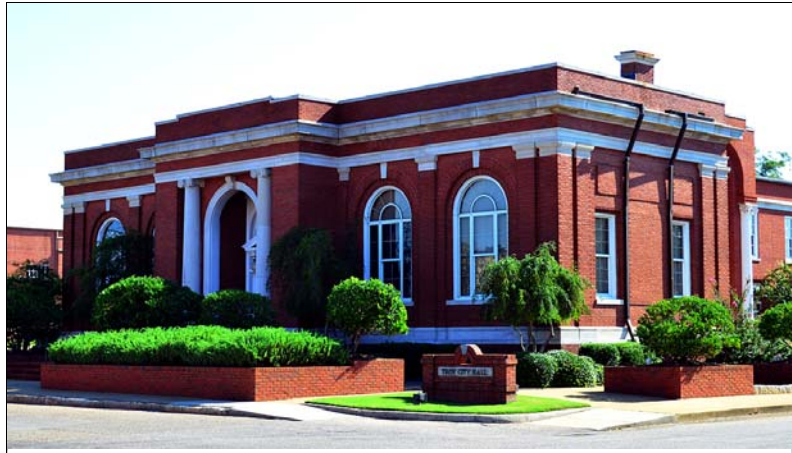
Figure 4.54. City Hall, southwest oblique.

Constructed in 1908 with the assistance of a \$10,000 grant from the Carnegie Fund, this building served as the Troy Public Library until 1920, when the City turned the building over to the Troy Normal School due to lack of funds. The school used this building for ten years and then returned the building back to the City in 1930 (Farmer 1992:229).

The original public library portion of the building was designed by Frank

Lockwood (Rice 2006:74). The building reflects a modest version of the Beaux Arts style, with key features including the paired pilasters, accentuated cornice, arched windows, and low pitched roof (Figure 4.54). The building's composition is central block with wings, as a projecting center section is flanked by two wider units giving the effect of a portico.

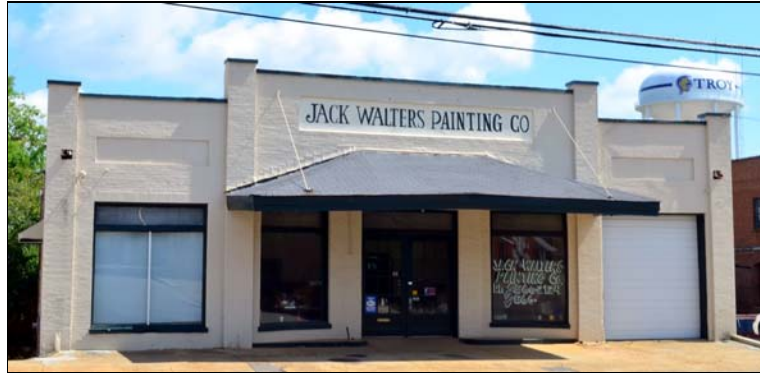
Figure 4.56. Walters Building, south elevation.

Sanborn maps first depict this building in 1931 (3) as a garage with 20 car capacity. The surviving building is a one story commercial vernacular brick structure (Figure 4.56). The front (south) elevation contains both pedestrian and vehicular entrances. A central pedestrian entrance consists of wooden French doors with single-pane fixed transom light. These doors are bordered by display windows with fixed single pane transom lights, all of which are shaded by an aluminum awning. An aluminum garage door for vehicle access is located on the right wing of the front elevation. A large display window with transom light is located on the opposite left wing.

Engaged brick columns border both the front elevation and awning. Three separate recessed masonry panels are located along a parapet with plain coping. Preservation condition appears to be good.

This building is considered potentially eligible for nomination to the *NRHP* under *Criterion A* due to its association with historic transportation, and for the Alabama Register under comparable criteria.

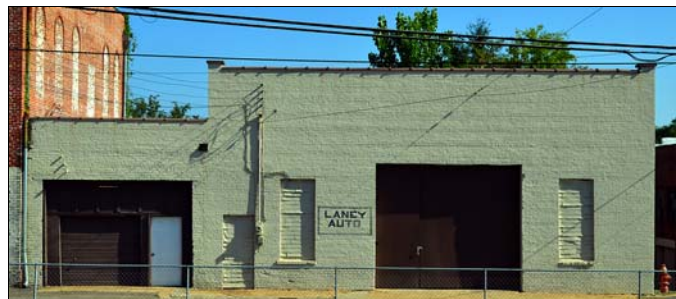
Figure 4.57. Laney Auto, south elevation.

This building was constructed as early as 1923 (Sanborn:3), and was used for auto repair and bottle storage as late as 1931 (Sanborn:3). The front (south) elevation has been altered with enclosed windows and freight/pedestrian alteration under a parapet with tile coping (Figure 4.57). The building has one and a half stories, with the half story located in the building's rear. Preservation condition appears to be good.

This building is considered potentially eligible for nomination to the *NRHP* under *Criterion A* due to its association with historic transportation, and for the Alabama Register under comparable criteria.

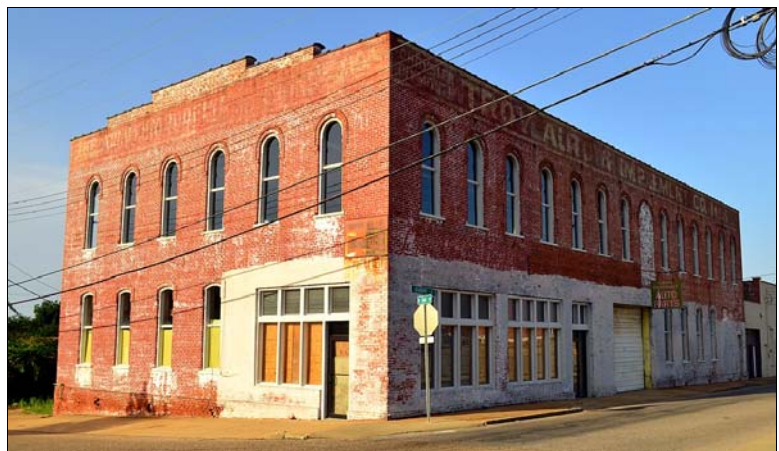
Figure 4.58. Troy Implement Company, southwest oblique.

This prominent two story brick building (Figure 4.58) was originally constructed to house Henderson Knitting Mills, with “knitting and finishing 1st (floor), carding and spinning 2nd” (Sanborn 1892:2, 1897:4). The building later housed J.M. Collier Wholesale Drugs and was “vacant 2nd floor” (Sanborn 1903:4), followed by a “20 car garage on the 1st (floor) and cotton factory on 2nd” (Sanborn 1916:4), then as a first and second floor garage for auto sales (Sanborn 1923:3). This building also served as an armory in 1931 (Sanborn:3).

All windows appear to have been updated with structural glass. First floor window and door composition appear to have been altered in layout and design through the addition of display windows and doors at the southwest portion of the building. A large aluminum freight/vehicle door is present on the street level south elevation; a similar freight door is present on the north second story elevation. Remaining original first floor windows have segmental arched lintels formed by two rows of soldiered brick; sills appear to be concrete. Second floor windows have semicircular arched lintels formed by two rows of soldiered brick; sills appear to be concrete. A centrally stepped parapet with tile coping is present on the west elevation; remaining parapets are level with tile coping. Residual painted signage (*Chrysler Plymouth...Troy AL Implement Company*) is located at the top of south elevation.

This building is considered potentially eligible for nomination to the *NRHP* under *Criteria A* and *C*, and for the Alabama Register under comparable criteria. This building is a strong contributing property to the historic character of Downtown Troy.

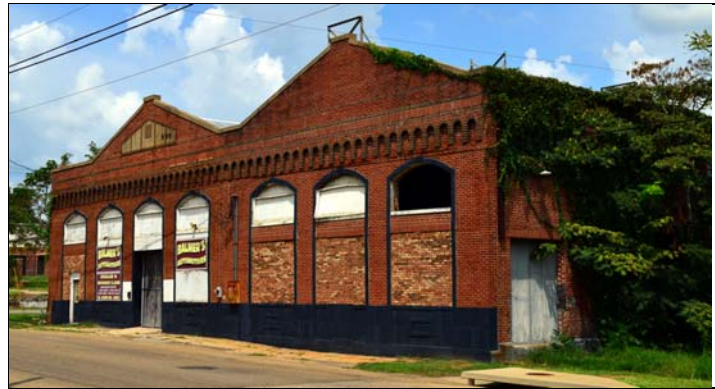
Figure 4.59. Balmer Building (old Light Plant), southeast oblique.

The 1931(14) Sanborn map appears to label this building as “Alabama Utilities Co. Elec. Light Plant”. The building is not depicted on earlier Sanborn maps. The north and west elevations are clad in tin, as is the roof. The front (south) elevation contains two and a half wings, with three large segmental arched lintel windows per wing, and one segmental arched lintel window in the half wing (seven arches, total; Figure 4.59). Five of these windows have been enclosed. One window appears to have been altered for use as a freight door. The far left window has been altered through the addition of a pedestrian door. A series of decorative small, connected semicircular arches spans the front elevation. A parapet with double gable design with plain coping tops the front elevation. The left parapet contains detailed paneling composed of concrete with header course brick border and detail. The east elevation contains a brick facade with an alternate freight door and other windows and doors that are obscured by dense vegetation.

This building is considered potentially eligible for nomination to the *NRHP* under *Criteria A* and *C*, and for the Alabama Register under comparable criteria. Further research is needed to determine this building's association with historic utilities development. This building is a strong contributing property to the historic character of Downtown Troy.

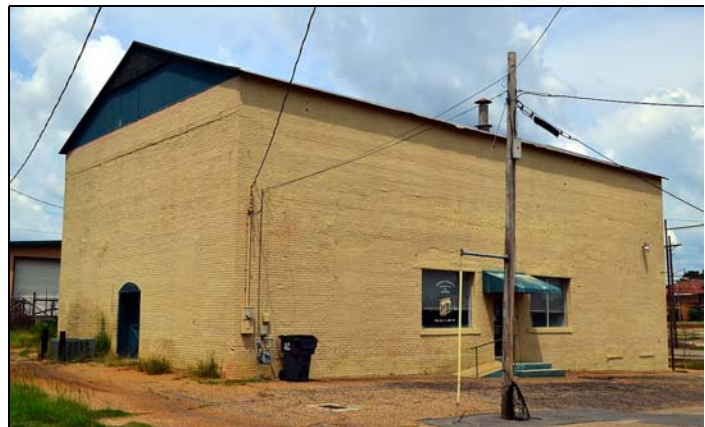
Figure 4.60. Co-op Gin Building, southeast oblique.

Built ca. 1916 (Sanborn:4), this one story brick building (Figure 4.60) provided seed via elevated conveyor belt to the Standard Chemical and Oil Company warehouse historically located east across Oak Street. Original three-row header course, semicircular arched lintel windows (eight total) with header course brick sills have been bricked over. A large, circular, bricked-over opening in the northern portion of the south elevation represents the location of the conveyor belt that once spanned Oak Street.

The current display windows and doors are contemporary alterations. The original entrance appears to have been via a large, wooden Dutch door under a three-row header course, semicircular arched lintel. Two opposing three-row header course, semicircular arched lintel windows border this door. The west and north elevations contain similar compositions of enclosed windows. Preservation condition appears to be good.

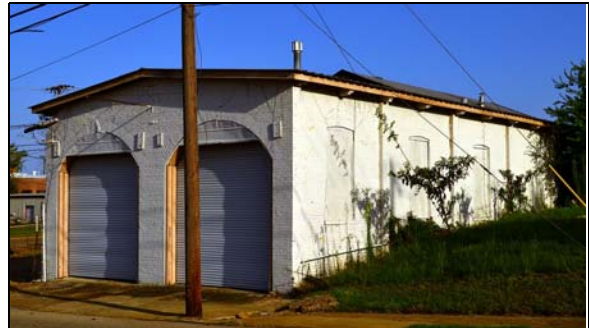
Figure 4.61. Troy Electric Pump House, northwest oblique.

This one-story brick building contains two freight door entrances with semicircular rowlock lintels on the north elevation (Figure 4.61). These entrances were originally designed to accommodate fire engines associated with Troy's first electric power generating plant, which was put into operation in May, 1891 (Farmer 1992: 362). The generator building was located in the northeast portion of Block 4, east and adjacent to this building. Sanborn maps from February 1891(1) depict the site of the planned generator building that was later constructed in May of that year. The adjacent surviving fire engine building (4-5.3, Figure 4.61) is later depicted as a pump house associated with the "Troy Electric Lights and Water Works" facility (Sanborn 1897:4; 1916:4), and later as a 'Fire Dept' associated with the "Troy Electric Lights and Water Works" on the northeast corner (Sanborn 1923:3). The original pump house at the rear (south) of this building once contained a 150,000 gallon water reservoir that is no longer present. This area appears to have been enclosed by a more recent concrete block addition. Symmetrical segmental arched lintel windows have been enclosed on the east and west elevations.

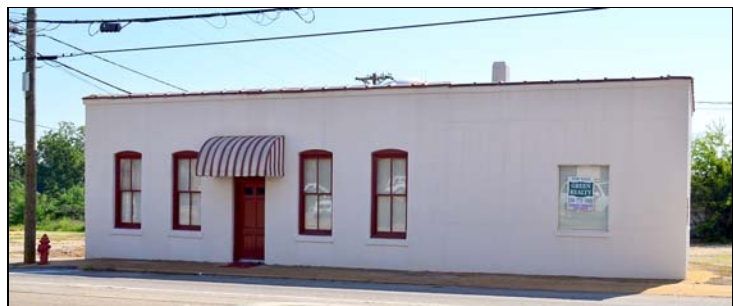
Figure 4.62. Building 4-5.1, west elevation.

Constructed circa 1920, this one story commercial vernacular building was originally used as office space (Sanborn 1923:3). The building contains an exterior fabric of stucco over brick, with a simple parapet with tile coping (Figure 4.62). Windows consist of 2/2 double hung wooden sash with segmental arch lintels. Preservation condition appears to be good.

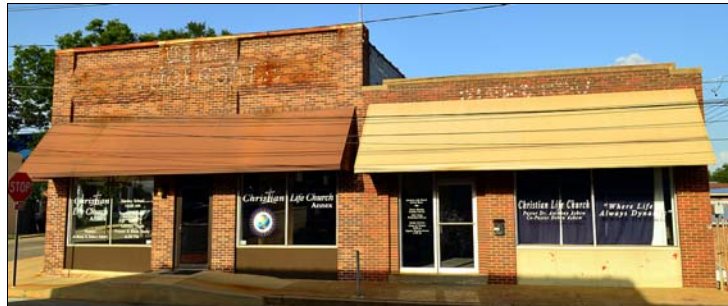
Figure 4.63. Buildings 15-58a and 15-58b, west elevation.

This two commercial vernacular building appears to be built or at least updated with relatively recent brick on the west and north elevations (Figure 4.63). The building contains a second semi-subterranean level with access from an unpaved lot at the south of the building. Street level attributes consists of modern display windows and doors. Property appraiser data indicates a 1910 construction date, but this building is not depicted on any Sanborn maps up to 1931. Both the front (west) and north elevations appear to have been updated with modern brick. Further research is needed to determine the construction date.

As with its adjacent north neighbor, this two story commercial vernacular building has been updated with relatively recent brick on the west elevation (Figure 4.63). The building also contains a second semi-subterranean level with access from a dirt lot at the south of the building. Street level attributes consist of modern display windows and doors. Property appraiser data indicates a 1910 construction date, but this building is not depicted on any Sanborn maps up to 1931. Further research is needed to determine the construction date.

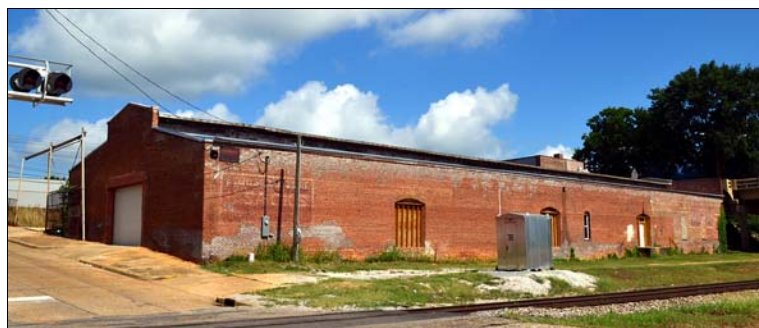
Figure 4.64. Henderson-Faulk Warehouse, southeast oblique.

This linear brick warehouse (Figure 4.64) is first depicted on Sanborn maps in 1916 (4) as the Henderson-Faulk Warehouse, general storage. The entrance at the north elevation originally opened directly onto Elm Street prior to construction of the Elm Street bridge in 1936. A small section of the brick street surface is present at the north end of the warehouse may be a remnant of Elm Street prior to paving. The

building retains large freight doors on the north and south elevations. Three freight doors with three-row header course segmental arches are present on the east elevation facing the railroad tracks. Windows facing the railroad tracks include one updated double hung sash with two-row header course semicircular arched lintel and three windows (bricked up) with jack arched lintels. All windows have header course brick sills. Similar window layouts are present on the west elevation. This warehouse appears to retain a majority of historic fabric and to be in good condition.

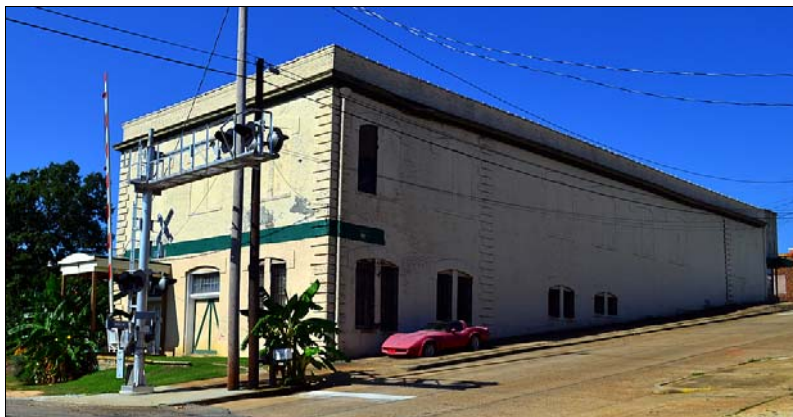
Figure 4.66. Troy Grocery Company, northwest oblique.

Founded in 1900, the Troy Grocery Company provided wholesale grocery supplies to Pike County and surrounding areas. Property appraiser data lists a construction date of 1900, but the building is not depicted until 1909 (8) on Sanborn maps. This two-story commercial vernacular building has been updated on the Market Street facade with relatively modern display windows and doors, as well as a large plywood-covered false front. The other three elevations contain windows that have mainly been plastered and painted over, as well as decorative quoins at building corners and at presumed wall supports. Dentile molding spans the south, east, and north elevations under a simple brick parapet. Two separate loading dock door entrances face the railroad tracks to the east (Figure 4.66). Preservation condition appears to be good.

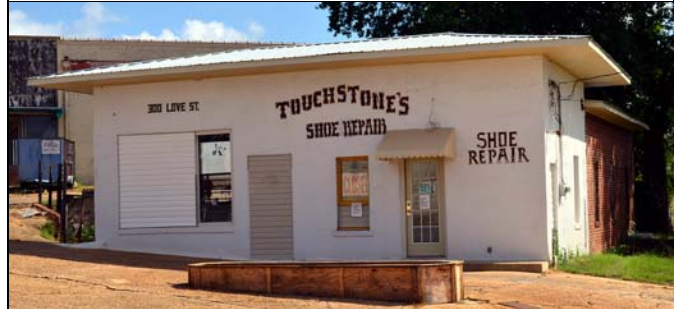
Figure 4.67. Touchstone's Shoe Repair, southwest elevation.

This one story commercial vernacular building is first depicted as a filling station on 1931 Sanborn maps (5). Windows and doors have been updated with modern replacements, but the building still retains a moderate degree of historic character (Figure 4.67). This building represents the last historic filling station in Downtown Troy, and as such is potentially eligible for *NRHP* nomination under *Criteria A*, and *C*. This building is eligible for the Alabama Register under the same general criteria and for its contribution to the historic setting of Downtown Troy.

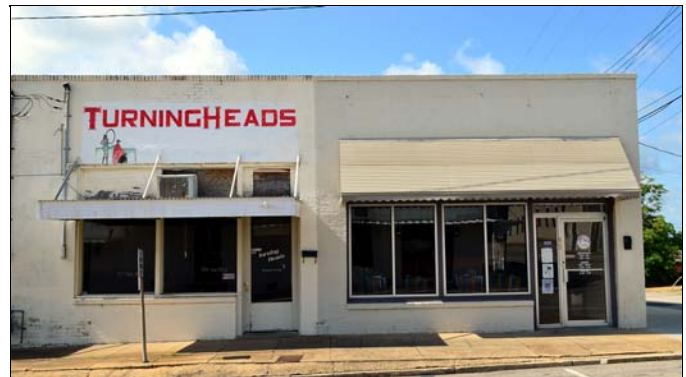
Figure 4.68. Buildings 22-43 and 22-42a, north elevation (right to left).

This one story commercial vernacular building is listed with the property appraisers with a construction date of 1910. However, Sanborn maps depict a similar brick building listed as a grocery at this location in 1897 (5). Modern door and window replacements are present, and the interior has been modified for use as a contemporary restaurant (Figure 4.68). Preservation condition is considered good.

Sanborn maps first depict this building as a barber shop in 1916 (6). Modern door and window replacements are present and transom lights over the display windows and door have been covered with plywood (Figure 4.68). The building appears to retain the original brick parapet.

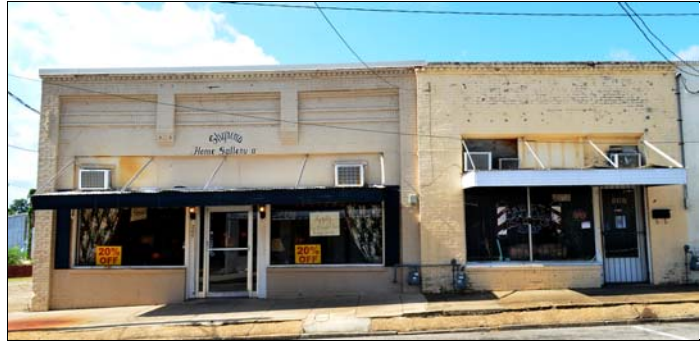
Figure 4.69. Buildings 22-42b and 22-42c, north elevation (right to left).

This one story commercial vernacular building is listed with the property appraisers with a construction date of 1920. Sanborn maps depict this building as vacant in 1916 (6). Modern door and window replacements are present and transom lights over the display windows and door have been covered with plywood (Figure 4.69). The building appears to retain the original brick parapet. Preservation condition appears to be good.

This one story commercial vernacular building is listed with the property appraisers with a construction date of 1920. Sanborn maps depict this building as a ten car garage in 1916 (6). Modern door and window replacements are present and transom lights over the display windows and door have been covered with plywood (Figure 4.69). The building retains the original corbelled brick parapet with more detailed brickwork than adjacent buildings. Preservation condition appears to be good.

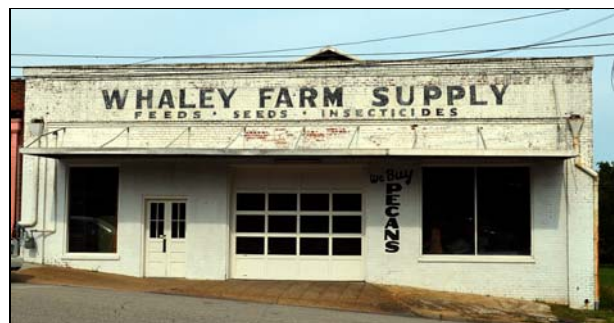
Figure 4.70. Whaley Farm Supply, west elevation.

This one story commercial vernacular building originally served as the TF Murphree Carriage Shop in 1916 (Sanborn: 6). The building most recently served as an agricultural supply business. The front elevation contains wood paneled double doors and two structural glass display windows under an aluminum awning (Figure 4.70). A large freight door is centrally located within the front elevation. A shed roofed brick addition is located on the building's rear. The south elevation contains ten three-row header course segmental arched windows that have been enclosed and covered with asphalt tile.

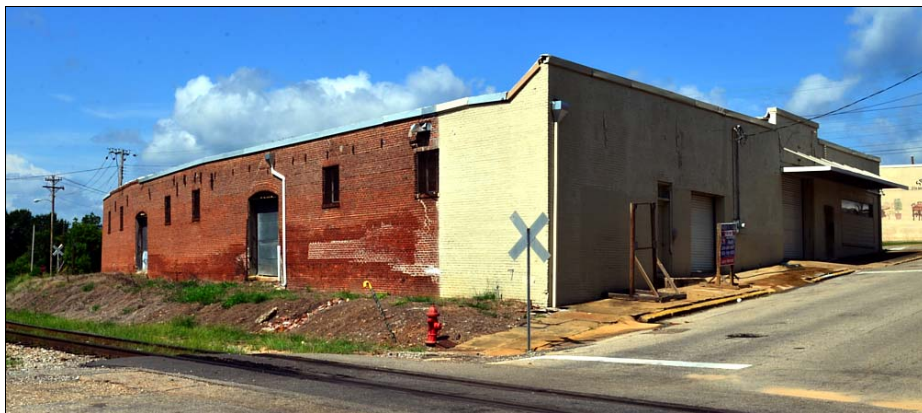
Figure 4.71. Seals Warehouse, northeast oblique.

This unique curved brick warehouse was constructed in several stages. The building's eastern curved wall boundary is defined by the adjacent railroad track right-of-way (Figure 4.71). The 1897 (5) Sanborn depicts the northern portion of this warehouse facing Love Street as the John Seals Cotton Warehouse. An open well is also depicted in the rear interior of the building. By 1916 (Sanborn:6) the warehouse has been expanded to encompass the entire curved lot, and was used for cotton seed storage. The building later served as J.S. Carroll Mercantile Company's Warehouse No. 2 for cotton seed storage in 1923 (Sanborn:5) and automobile storage (with dirt floor) in 1931 (Sanborn:5). Preservation condition is considered good.

Two freight doors with three-row header course segmental arches are present on the east elevation facing the railroad tracks. Six steel covered, jack arched lintel windows with header course brick sills are present on the east elevation facing the railroad tracks. Similar window and door compositions are present on the west elevation. Two freight doors, two pedestrian doors, and one partially covered display window on the north elevation have been updated with modern trim and components. Additional windows have been covered over and updated. This warehouse appears to retain a majority of historic fabric and to be in good condition.

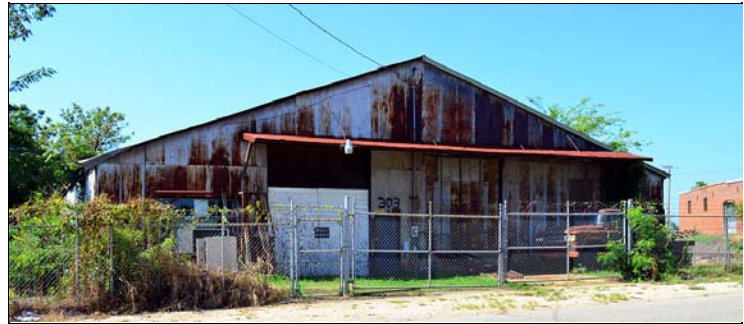
Figure 4.72. Carroll Warehouse No. 3, north elevation.

Located between the Seaboard Coastline and Central of Georgia railroad tracks, this nondescript warehouse was originally used for grocery and hardware storage (Figure 4.72). The 1916 Sanborn map (5) depicts this tin-covered structure as the “J.S. Carroll Mercantile Co’s W.Ho. No. 3”. In light of the building’s current condition, it is interesting to note that the 1931(5) Sanborn map depicts the building’s use as junk storage.

This building does not appear to meet *NRHP* eligibility criteria due to building materials and architectural attributes. This building is considered potentially eligible for nomination to the Alabama Register based on its role in local commerce and industry. Further research is recommended to determine the research potential of interior architectural details and historical associations. Preservation condition is considered moderate.

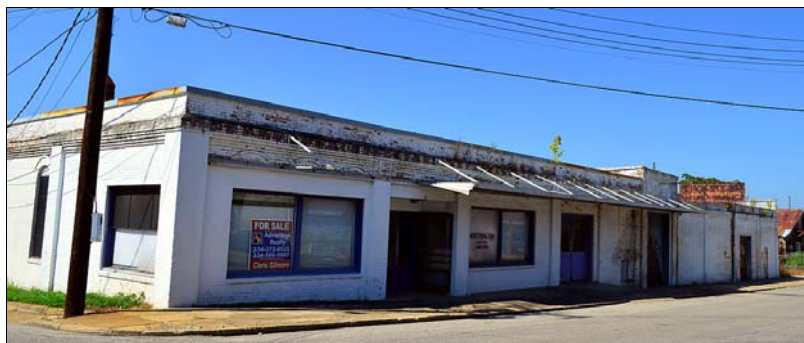
Figure 4.73. Thompson Warehouse, northeast oblique.

This brick warehouse was originally built circa 1920 for use as a cotton warehouse (Sanborn 1923:5). Portions of the structure have been updated with contemporary office spaces. Numerous freight and pedestrian entrances, and segmented and semicircular arched windows surrounding the warehouse exterior have been bricked up and modified over the years (Figure 4.73). This building continues to function as a warehouse and appears to be in moderate condition.

This building is potentially eligible for the *NRHP* eligibility criteria under *Criteria A*. This building is considered potentially eligible for nomination to the Alabama Register based on its association with the development of commerce and industry. Further research is recommended to determine the research potential of interior architectural details and historical associations. Preservation condition is considered moderate.

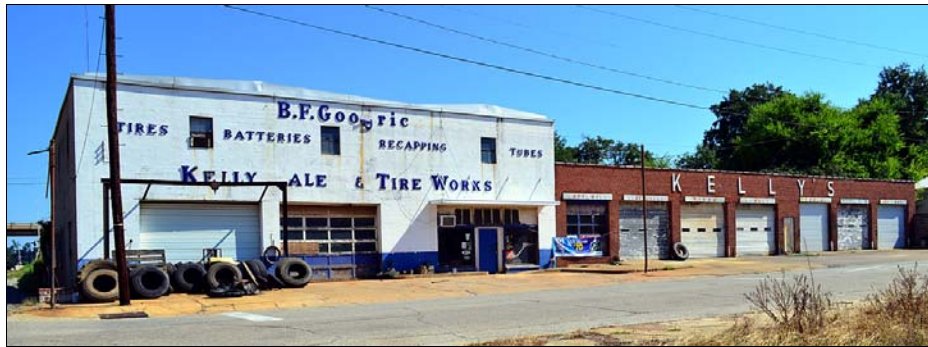
Figure 4.74. Kelly's Tire Building, south elevation.

This two story commercial vernacular brick complex contains components with differing dates. The earliest circa 1920 building appears to be the two-story structure adjacent to the railroad tracks. This building has been substantially altered with modern freight doors and contemporary windows. The more recent addition on the west (circa 1960) is a six bay structure for automobile repair (Figure 4.74). Preservation condition appears to be moderate.

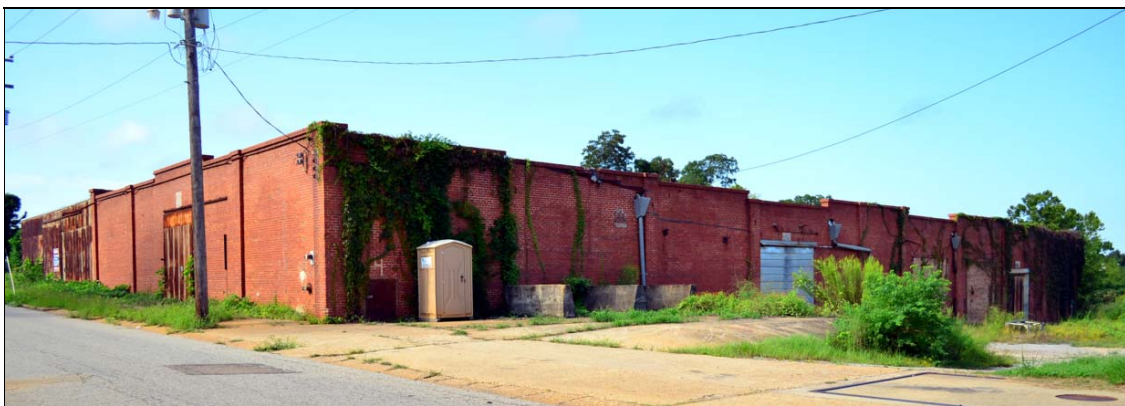
Figure 4.75. Sessions Warehouse East, northeast oblique.

Property appraisers data lists a 1920 construction date, but Sanborn map research indicates that the brick structure was constructed sometime after 1931. This sprawling warehouse contains numerous freight and pedestrian doors (Figure 4.75). Building materials include both tin and brick, with a stepped parapet surrounding the top of the brick portion. Preservation condition appears to be moderate.

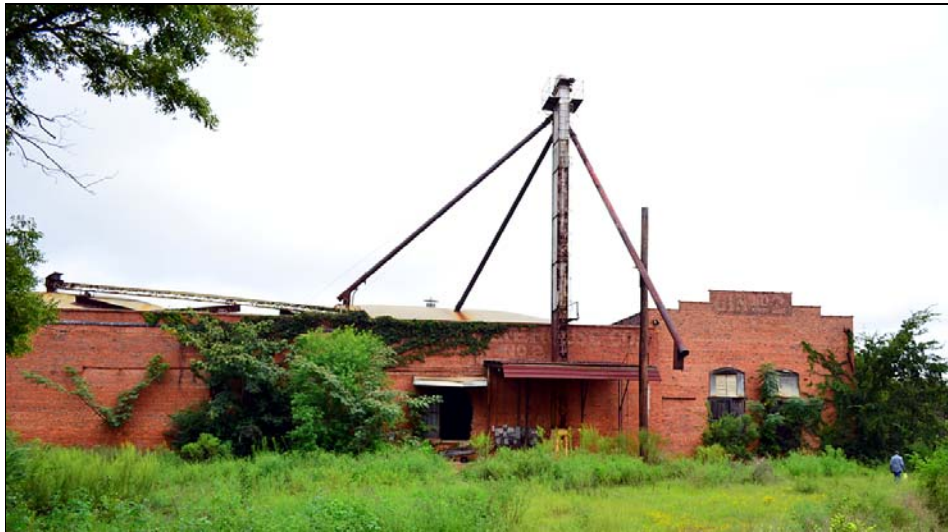
Figure 4.76. Alabama Warehouse No. 2, south elevation.

Located at the corner of Youngblood and Oak Streets (an unnumbered Sanborn block), this brick warehouse originally served as a cotton processing and storage facility. Ginnery No. 2 was located within the eastern portion of the building and is labeled as such with residual painted signage on the southern elevation under a stepped parapet (Figure 4.76). A square-bale cotton compress was located within the larger western portion. A small attached office with brick exterior is located on the northeastern corner of the main warehouse (Sanborn 1931:2). Property appraisers data lists a 1900 construction date, but Sanborn map research indicates that the brick structure was constructed between 1923-1931. Preservation condition appears to be moderate. This building is considered potentially eligible for nomination to the *NRHP* under *Criterion A* for its role in the development of local agricultural industry, and is potentially eligible for the Alabama Register under comparable criteria and for its contribution to the historic setting of Downtown Troy
